JT2 - Bldg Imp. Masonry Repair

Constructed in 1990-1991, the Intermediate School is a three story steel framed structure clad with brick masonry, architectural stone units, framed (punched) windows, glass storefront areas and cast stone. In the 25 years since its completion, various areas of the building envelope have developed significant signs of deterioration. These areas of deterioration are observed in brick, cast stone components, steel lintels, masonry site walls and sealant joints.

Based on the above, DEI was engaged to conduct a condition assessment of the building envelope to evaluate and determine the causes of deterioration, assess the extent of component damage and develop a preliminary scope and budget for restoration. This investigation phase included close-up observations of conditions using a manlift and cutting probes into various envelope components to facilitate a detailed analysis of the causes of facade deterioration.

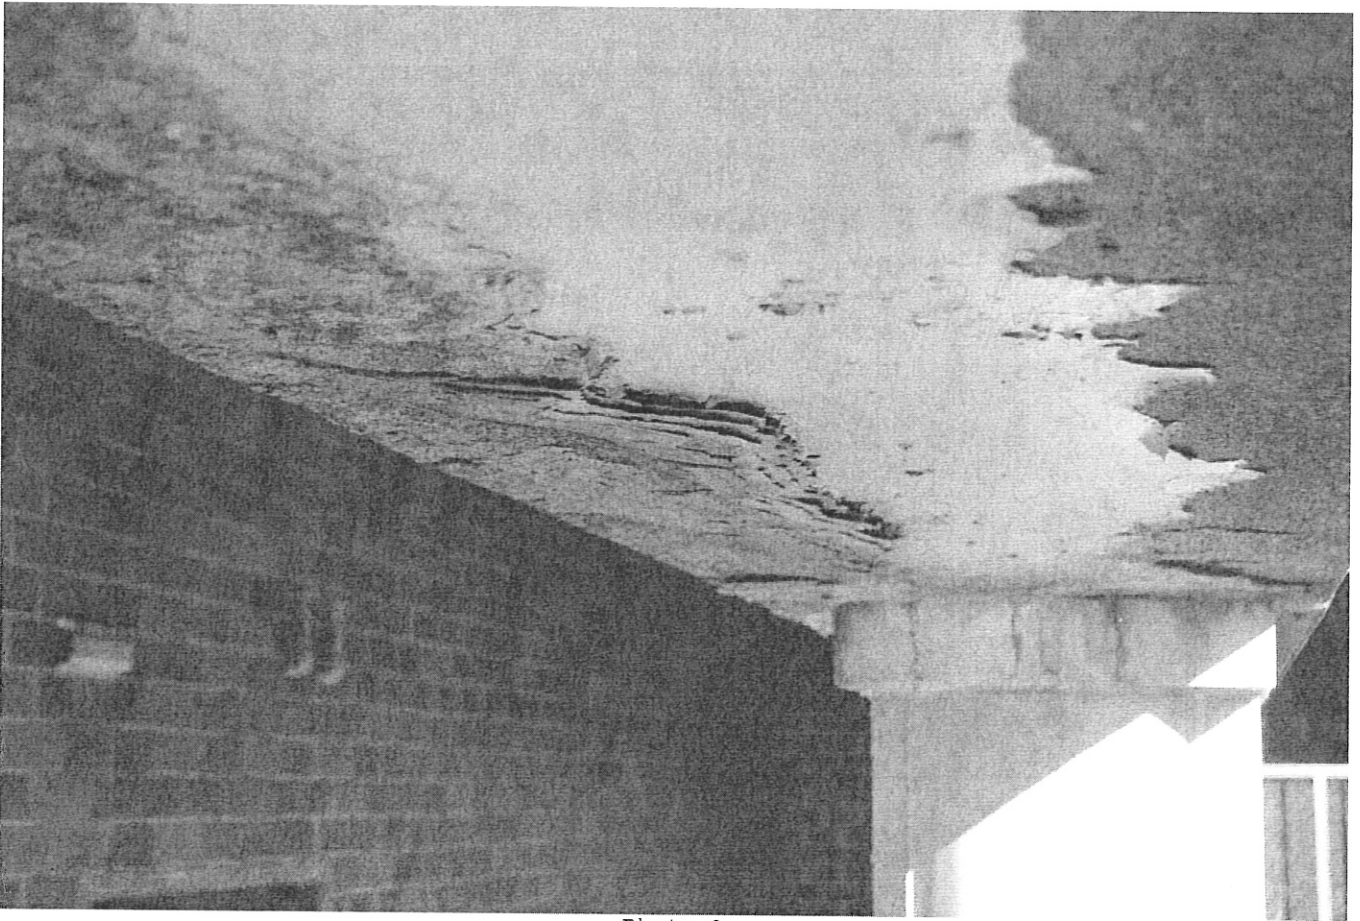
Photo 9

2. Continuous drip edges were not provided at flashing edges. Drip edges are important because they cause water that exits the wall at the flashing line to drip clear of the building face (Reference Detail B on sketch SK-4). In the absence of drip edges, the water is able to return back along the underside of the steel lintels via surface tension and promote corrosion deterioration (Photos 9 and 10).

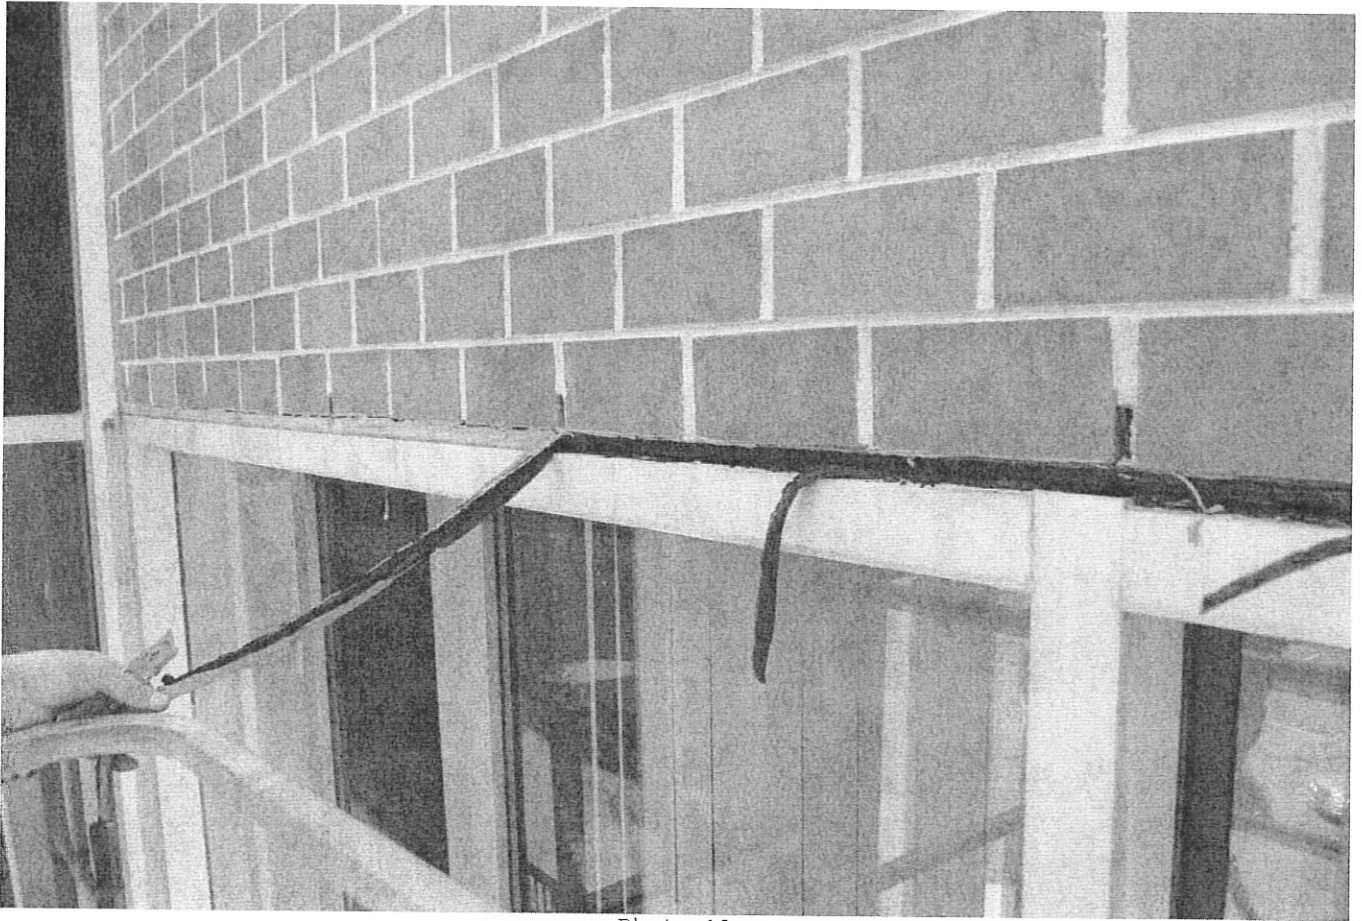
Photo 13

3. The flashing above window head areas is not turned up or dammed at its ends. Water which reaches the flashing can flow horizontally to the ends of the flashing and then down into the wall structure. This condition was observed at window openings in areas of the brick veneer (Photo 11 from probe #14).
4. At some locations, the weep tubes were not located directly on top of the flashing, but on top of the mortar joints, which results in cavity water having to build up on the flashing before it can drain out of the wall (Photo 12).
5. At some locations sealant was applied between the lintel and the veneer units above, trapping moisture on the lintel assembly behind it (Photos 13 and 14).

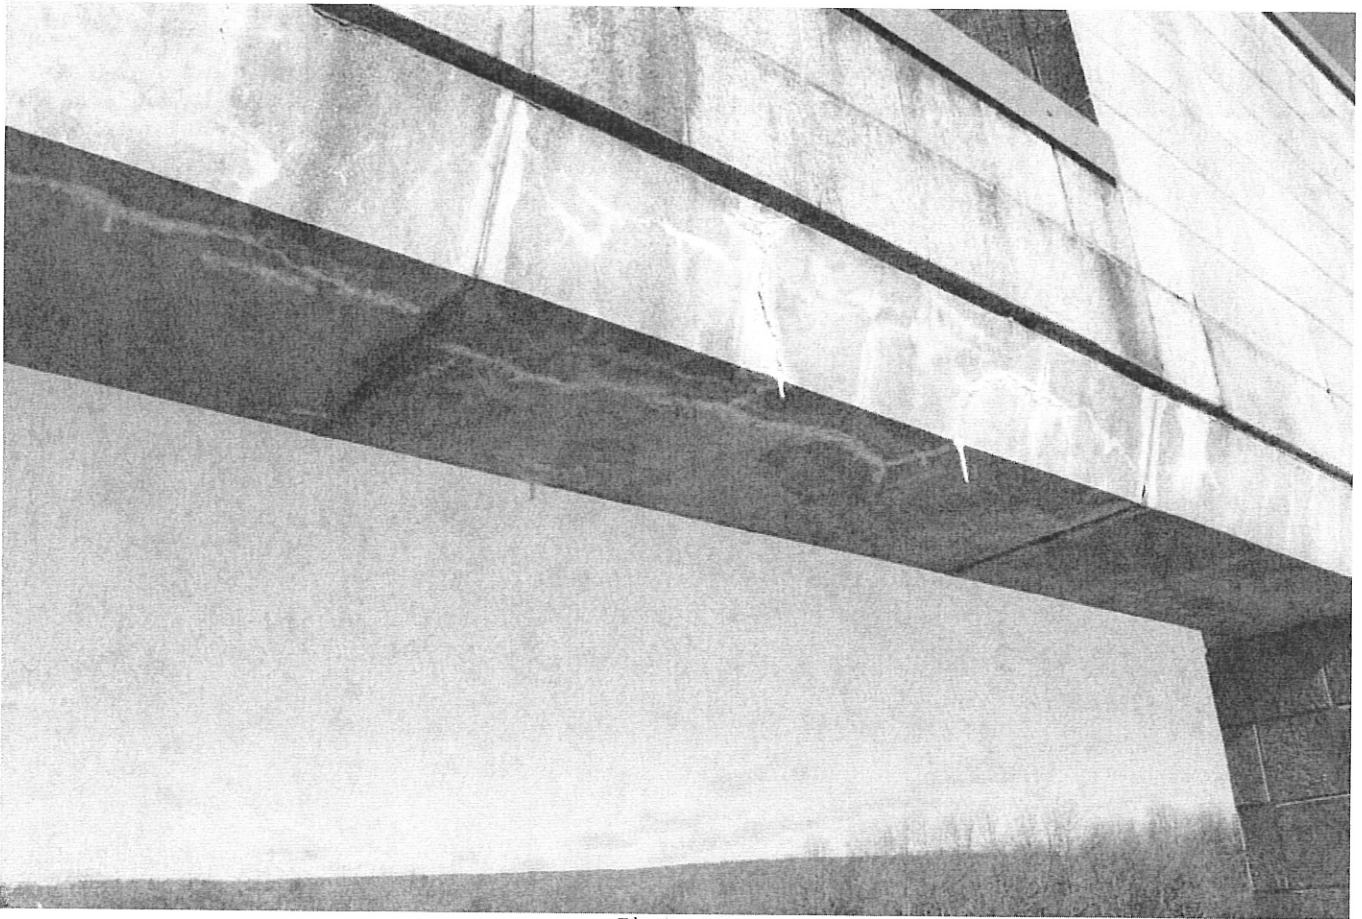
Photo 15

On this project, the cracking described above was observed at all three classroom wing entrances (Photos 15 and 16) and at site wall coping caps (Photos 17 and 18). In addition, it is evident by the staining and brick deterioration observed at various top of wall areas on the building (Photos 19 and 20), as well as from our review of the original drawings, that cast stone copings were utilized to cap some of the building walls in the original construction. Most of these original cast stone caps have since been replaced with bronze colored aluminum coping caps. Interestingly, cast stone window sills currently do not evidence signs of ASR.

- 5.1 Cast Stone Pieces (High Priority) - Given the extent of cracking, the known material deficiencies, the ineffectiveness of flashing and weep holes, and the ongoing exposure to water intrusion it is not feasible to attempt to rehabilitate the remaining cast stone pieces (with the exception of window sills). In addition, due to the current advanced state of deterioration of many of the pieces, we recommend that the deteriorated cast stone pieces be removed and replaced with limestone pieces. We anticipate that this work will include the following:
- a. Demolition and disposal of cast stone pieces
 - b. Scraping, priming and painting existing exposed steel lintels
 - c. Proper installation of new flashing and weep systems
 - d. Installation of new limestone in lieu of cast stone pieces

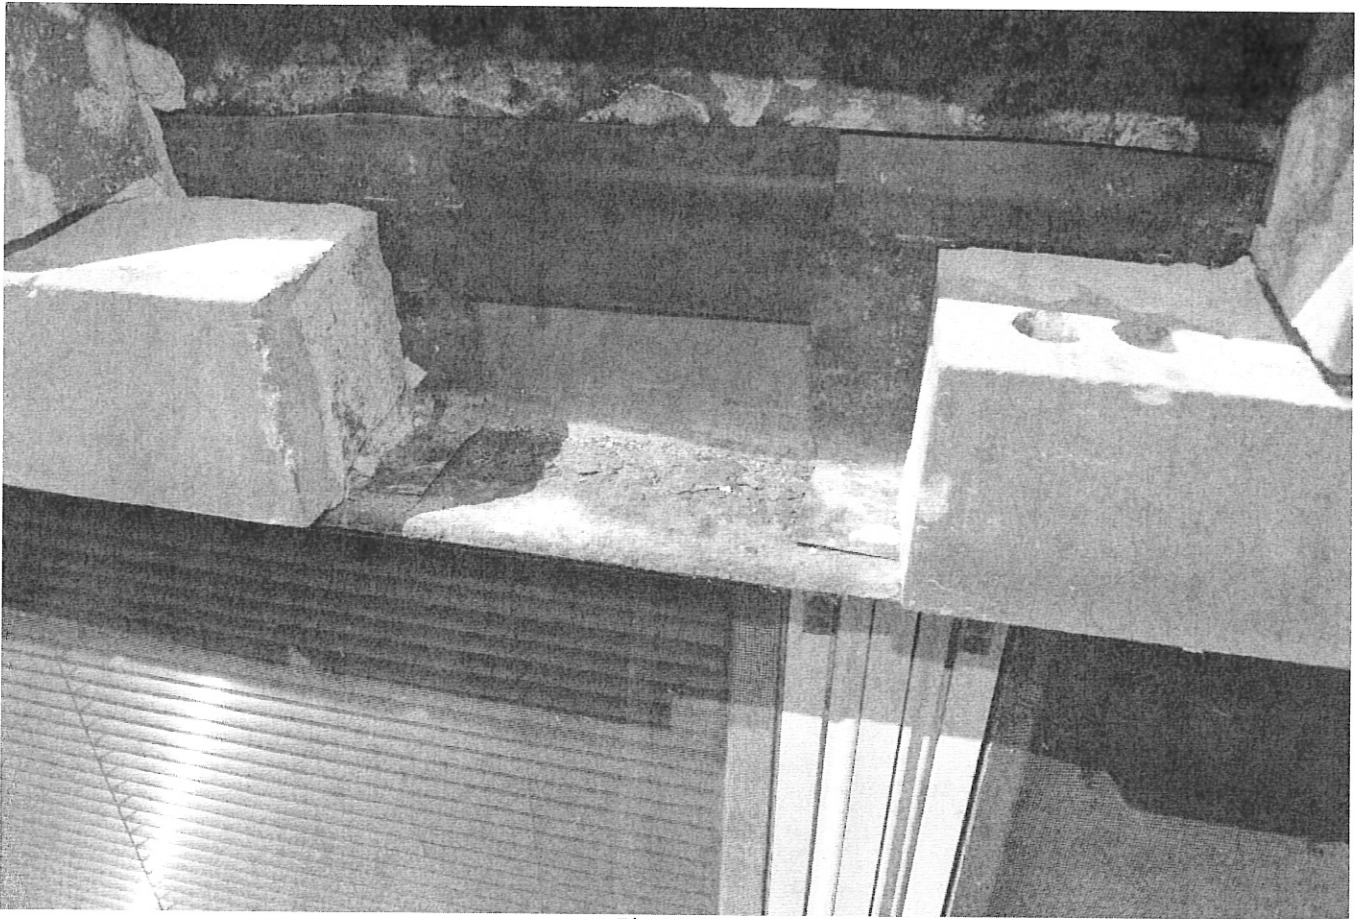
Photo 21

There are approximately 97 window openings around the building. Windows consist typically of double hung units 3'-4" in width that are arranged in multiple units up to a maximum overall width of 13'-4". Brick masonry above these window openings is supported on steel lintels that span across the opening and bear on the brick masonry at each side of the window. Masonry Probes #2, #4, #5 and #14 were made above and adjacent to window heads. At each of these probes, existing flashing and weep holes are present, but they are not functioning properly due to the conditions noted above under section 4.1. This has resulted in the corrosion of steel lintels at some window head locations (Photo 21).

- 5.6 Window Heads (Medium Priority) - Currently there is a variation in the extent of deterioration observed on window lintels. This variation is believed to be related to environmental conditions unique to each lintel location, such as exposure to wind, sun and rain as well as the quality of original workmanship, etc. Although repairs may not be warranted at all window head locations, there are some window head lintels that should be addressed due to the extent of oxide jacking and steel corrosion. We anticipate that corrective work in these areas will include the following:
- a. Removal of brick above window
 - b. Cleaning and coating steel lintel at heads of windows
 - c. Installing new membrane flashing
 - d. Installing weeps
 - e. Reinstalling brick
 - f. Replacing sealant between the bottom of the lintel and the head of the window frame

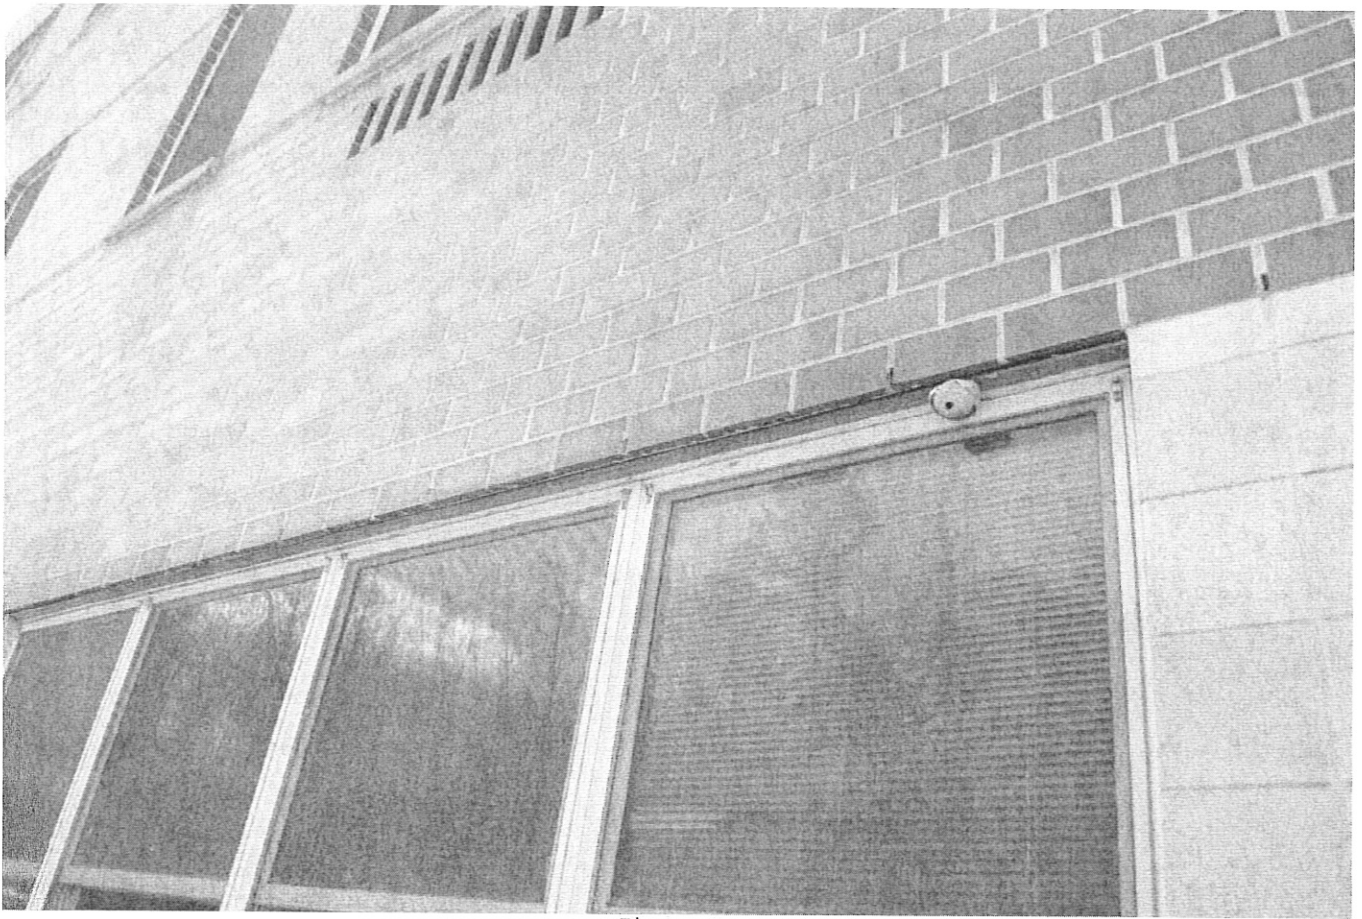
Photo 23

We did observe some locations where the membrane flashing was extended beyond the toe of the steel lintel angle, protecting the top surface from water, and with a drip that expels water away from the underside of the angle. At these locations the steel lintel remains in good condition (Photo 23).

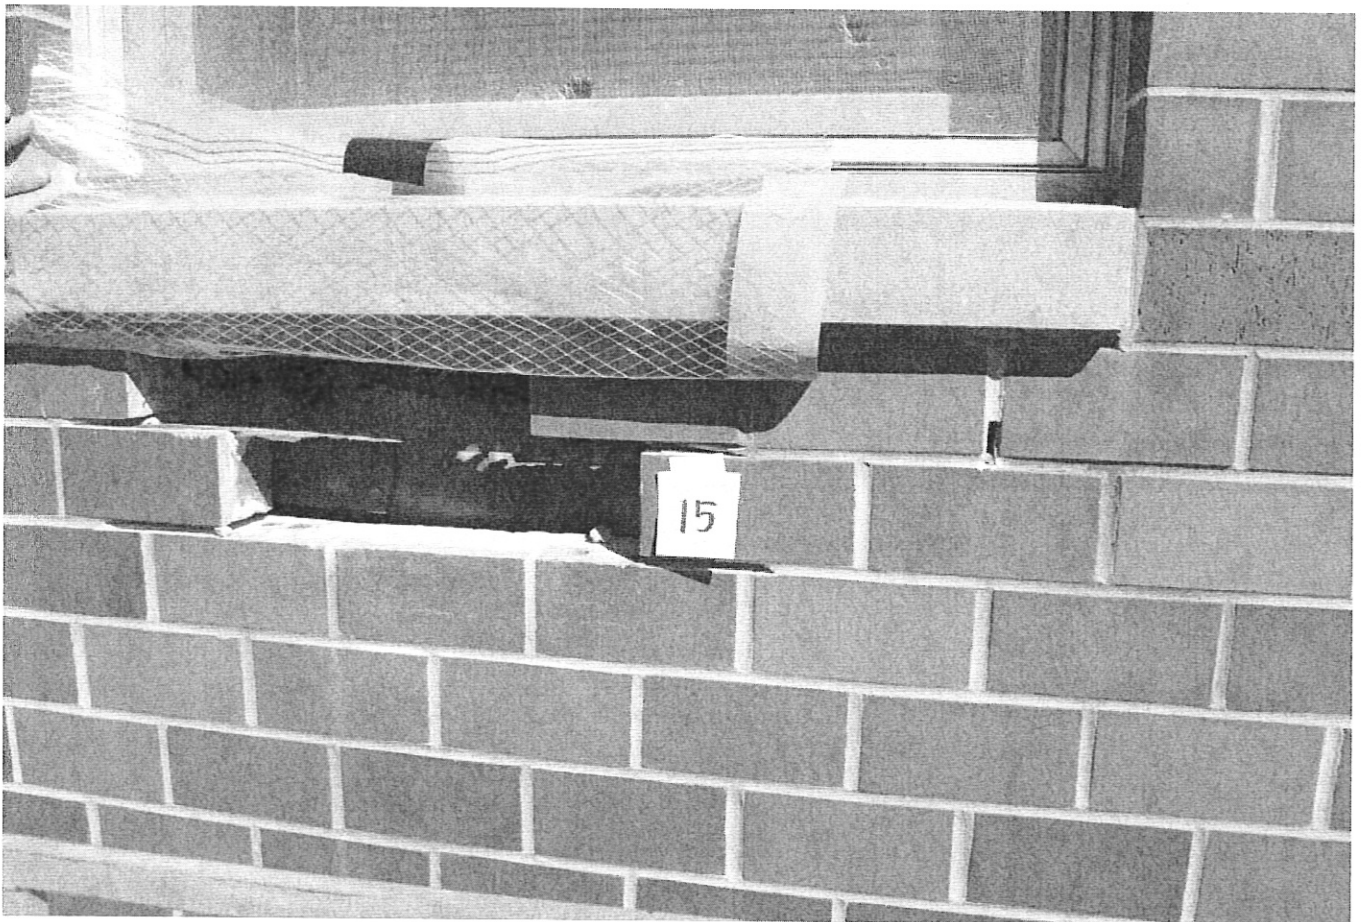
Photo 24

Cast stone sill pieces are located below window openings. The sill units are typically 3'-4" in length and are arranged in multiple units consistent with the window unit installations as noted above. The head joints between sill pieces are filled solid with mortar and sealed at the surface of the joint with an elastomeric sealant, which is in various stages of deterioration. The sills bear directly on masonry veneer units below. Unlike other cast stone elements around the site, the sill units appear to be in good condition. Based on our field surveys and probes, flashing and weep holes are provided under the first course below sill locations. Masonry Probes #6 and #15 were made to confirm flashing below sill pieces. Flashing was found at both locations and was observed to be terminated approximately $\frac{5}{8}$ " back from the exterior face

of the brick veneer (Photo 24). There is no steel in this area that could be subject to corrosion deterioration.

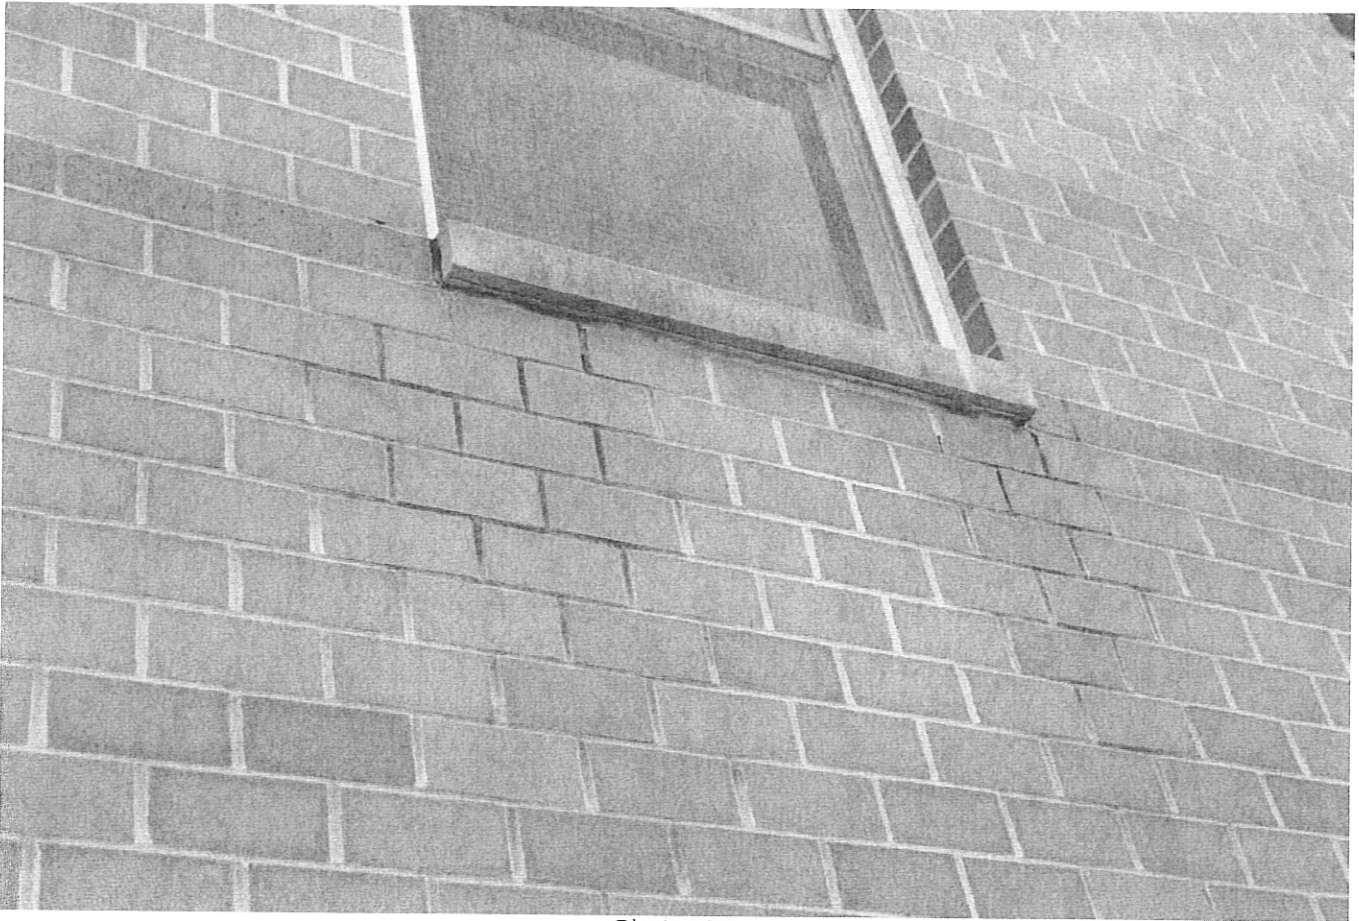
Photo 27

There is a drip profile formed at the underside of the cast stone sill so that water running down over the sill will drip clear of the masonry below the sill (Reference Detail B on sketch SK-5). At a number of locations, the drip has been covered over with sealant (Photo 25) or mortar (Photo 26), which has resulted in water returning back under the sill and following the sealant down onto the masonry veneer below the sill (Reference Detail A on sketch SK-5). This chronic wetness experienced in some brick masonry areas below the window sills is causing fungal growth and associated staining (Photo 27).

- 5.7 Window Sills (Medium Priority) - Chronic wetness in the brick masonry veneer, as evidenced by staining of the brick and mortar below a number of sill areas, can have a detrimental effect on long term veneer performance. In order to reduce the moisture exposure in these areas, we recommend the following scope of work:
- a. Removal of sealant material from the brick and sill at the underside of sill
 - b. Saw cutting the mortar bed joint below the sill back a minimum of ¼" from face of brick and repointing with mortar
 - c. Cleaning out the drip groove at the underside of the cast stone sill and reestablishing a continuous drip groove under the entire length of the sill

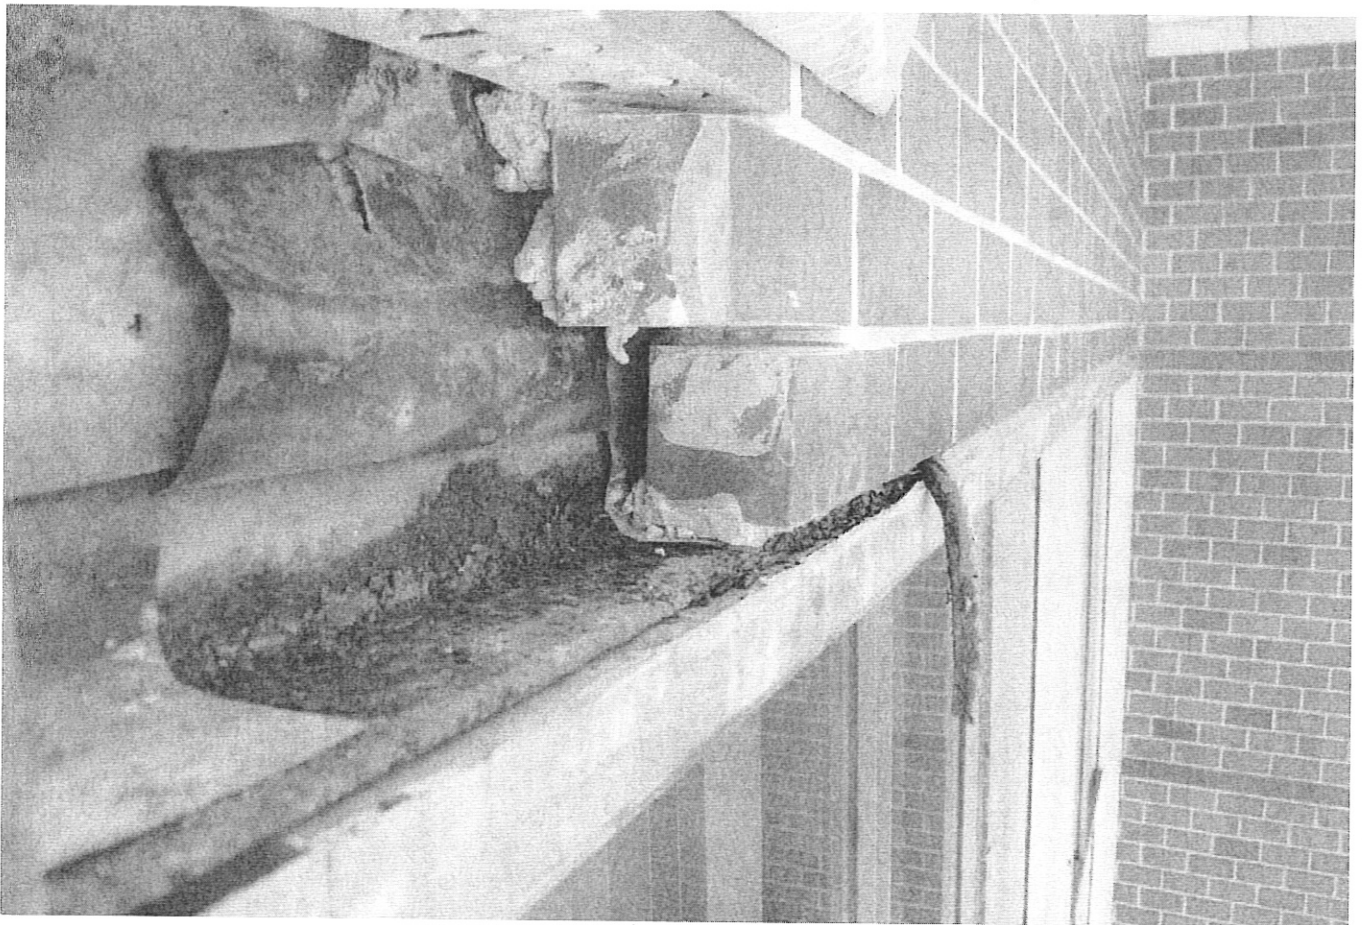
Photo 28

Steel lintels above storefront window systems and above metal louvers on the exterior wall of the boiler room are flashed similar to those above window heads in that the flashing does not extend fully over the steel (Photos 28 and 29). At these locations however, the detail is made worse by the application of a sealant joint between the top of the storefront (or louver) frames and the underside of the brick above. This sealant joint traps moisture on top of the steel lintel resulting in severe deterioration of the steel at these locations (Photos 30 and 31). The buildup of corrosion product on the angle above one of the louvers is so extensive it has caused deformation in the top of the louver frame below (Photo 32). The storefront areas are also known to be locations of water intrusion into the building. In addition to brick removal and re-flashing of these areas, it may be necessary to reinforce or replace the steel lintels due to the significant loss in their cross-sectional area as a result of corrosion deterioration.

- 5.2 Storefront Heads (High Priority) - Due to the extent of water infiltration and steel lintel deterioration at storefront head locations, retrofit repairs are imperative. We anticipate that the required repairs will include the following:

- a. Removal of brick above the storefront area
 - b. Cleaning and coating the steel lintel
 - c. Reinforcement or replacement of the steel lintel
 - d. Installing new membrane flashing

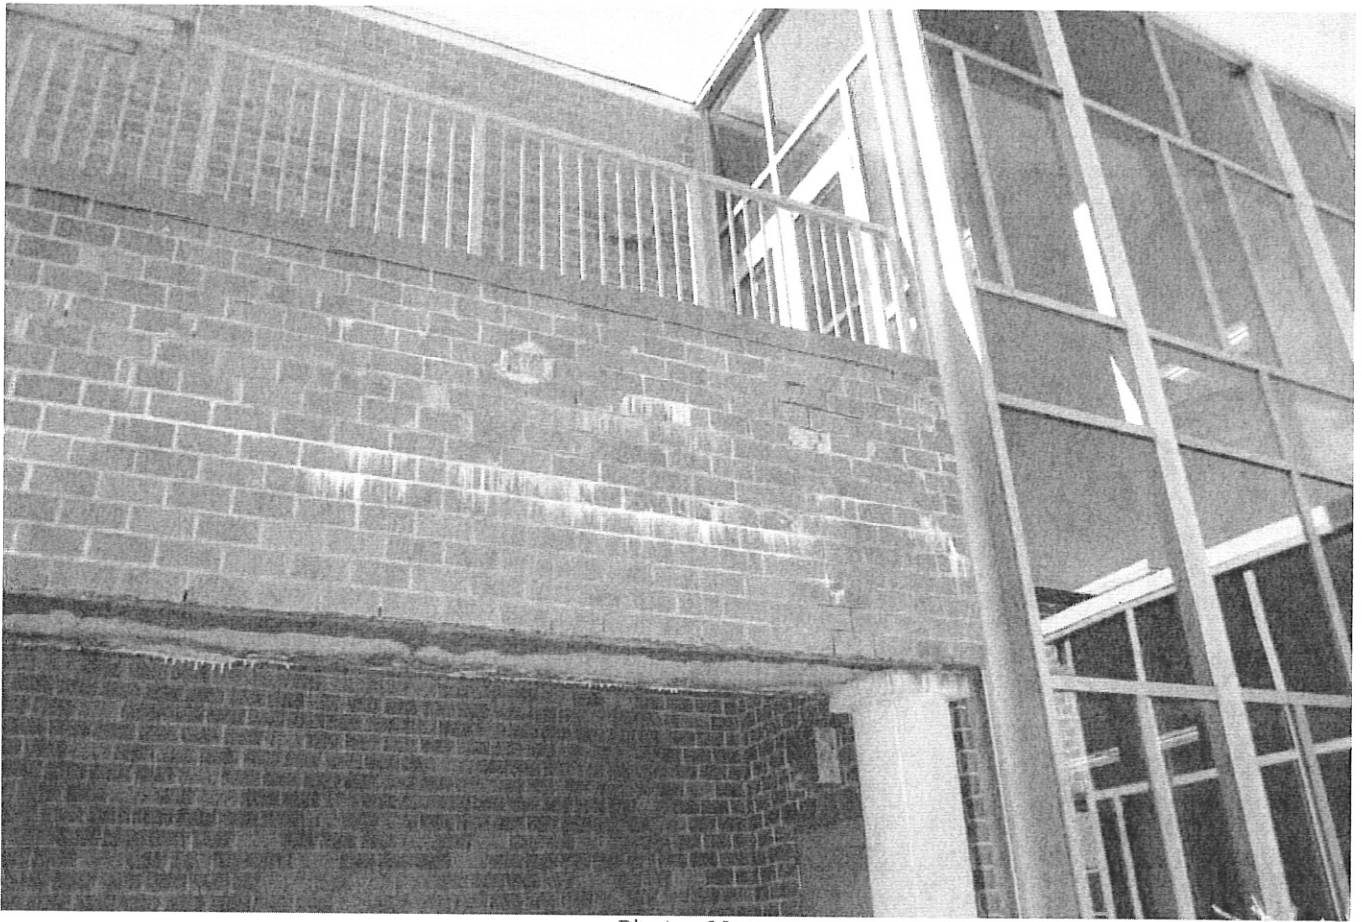
Photo 33

Efflorescence and brick spalling were observed at various locations around the building (Photos 33 and 34). Efflorescence is a white, powder-like deposit caused by soluble minerals within the wall being carried to the face of the wall by moisture and deposited as residue when the water evaporates. These mineral deposits evidence not only the penetration of water into the masonry walls, but more problematically indicate that the walls may not be sufficiently expelling it. Brick spalling occurs typically in cold, wet climates. When brick is exposed to water consistently, some of the water is absorbed through the porous material of the brick. When this water freezes and thaws repeatedly, it causes the face of the brick to crack and fall apart. The amount of damage is dependent on the amount of water, the absorption characteristics of the brick, and the number of freeze/thaw cycles. Given the amount of efflorescence and spalling observed at various locations around the building, it is apparent that at these locations, the brick masonry was exposed to chronic and significant moisture.

- e. Installing weeps
 - f. Reinstalling brick
- 5.3 Brick Spalling and Efflorescence (High Priority) - Brick spalling and efflorescence are observed occurring together at various locations on the building. Areas of spalled brick should be addressed by removal of the existing damaged brick and reconstructing the veneer with new brick. New flashings and weeps should be installed, where appropriate. At areas of efflorescence where brick remains intact, the brick should be cleaned using appropriate methods and cleaning products.

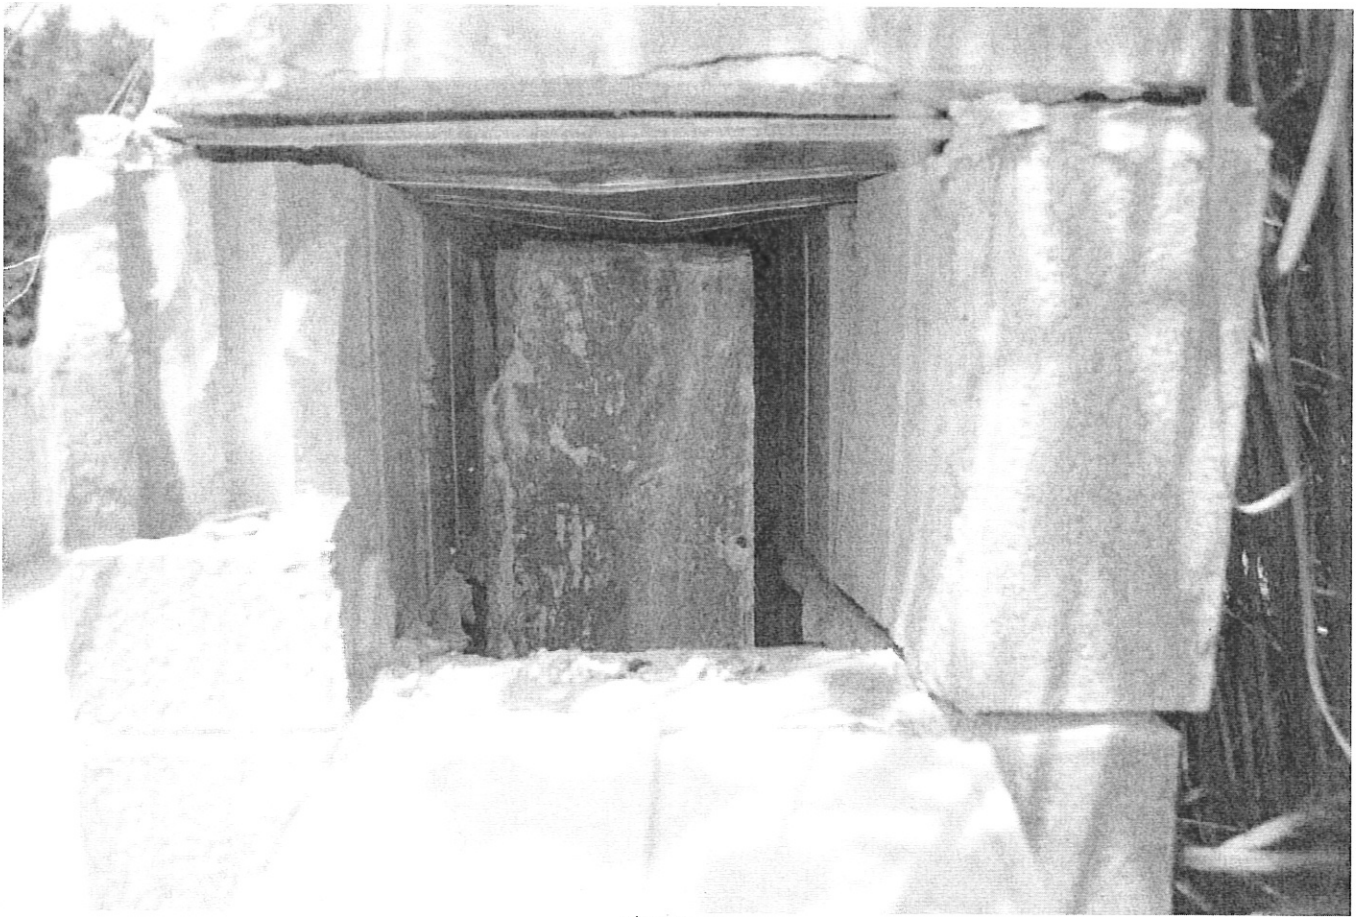
Photo 35

architectural stone block and capped with cast stone coping pieces (Photo 35). Probes performed into the veneer areas of two site walls (probes #25 and #26) revealed that there are masonry wall ties connecting the architectural stone veneer back to the concrete structural wall behind the veneer. The site walls currently exhibit severely deteriorated masonry with freeze-thaw damage, broken mortar joints, loose masonry that is no longer bonded together, cracks in the masonry, and spalling masonry units.

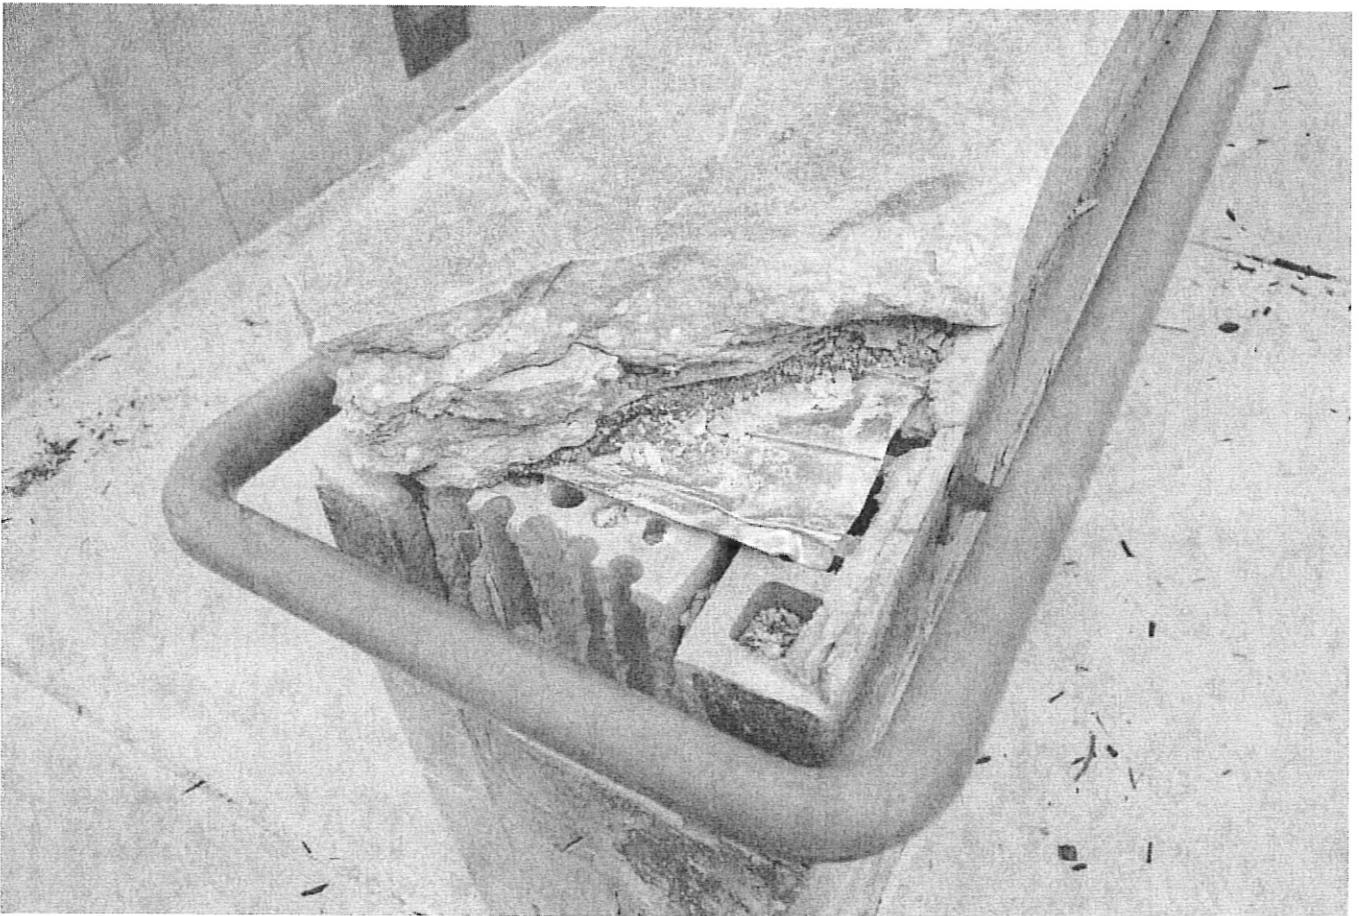
Photo 38

A broken piece of cast stone cap was removed to observe the flashing conditions below the cap. A stainless steel flashing is present below the caps; however, the flashing is held back 2" from the exterior face of the veneer below (Photo 38). Thus, water entering through cracks or joints in the caps drains off either side of the flashing directly into the top of the architectural stone veneer (Reference sketch SK-6). As damage occurred in the veneer, more openings were created which further increased moisture intrusion and additional deterioration (Photo 39).

- a. Demolition and disposal of cast stone caps
 - b. Installation of new stainless steel ties as required to construct new brick masonry
 - c. Proper installation of new flashing and weep systems

- d. Installation of new stainless steel cap flashing
 - e. Installation of new limestone coping caps or poured in place concrete caps with proper anchorage

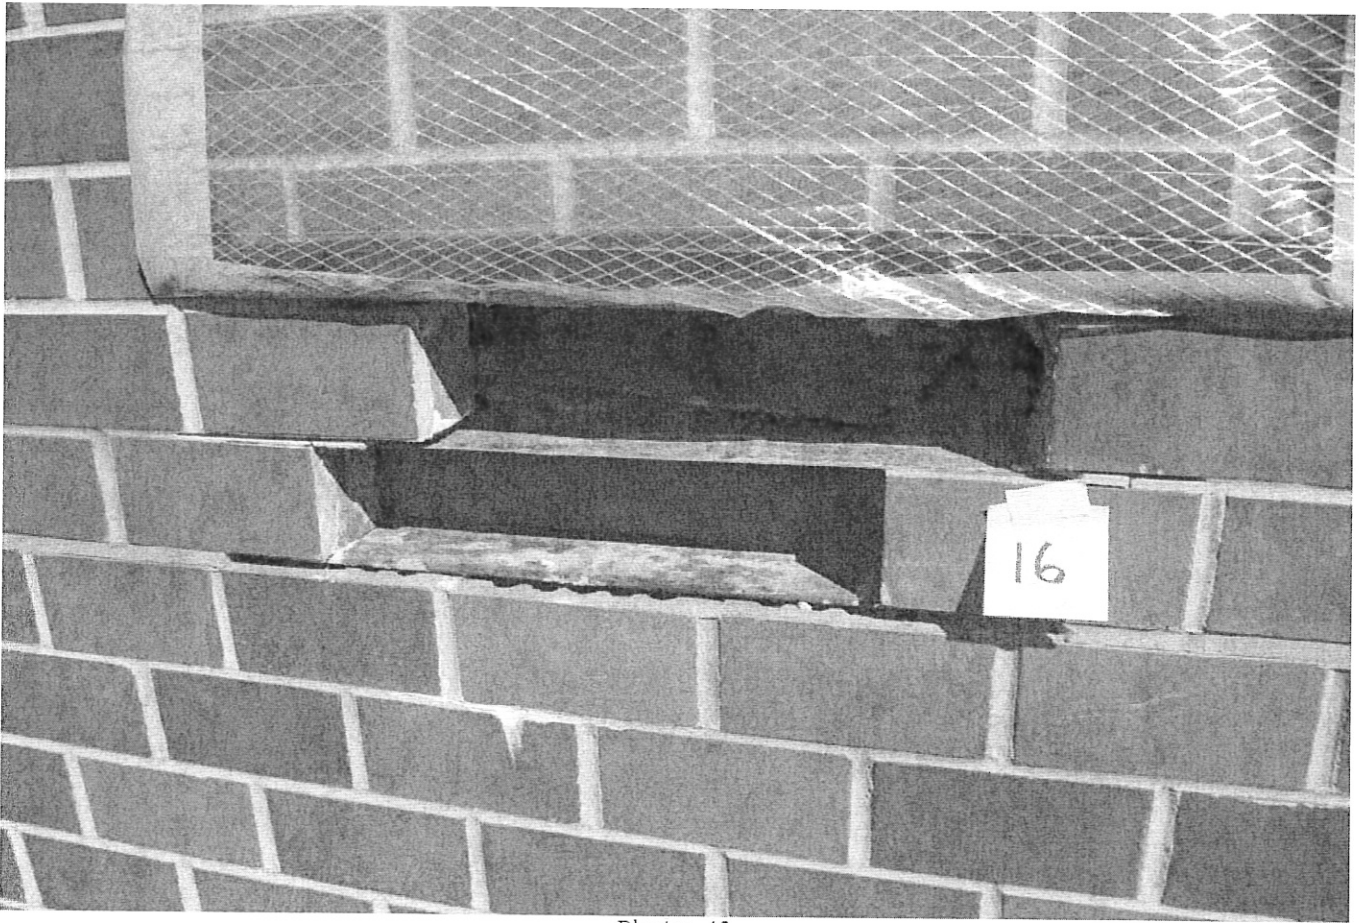
Photo 43

We performed probes at several relief angle locations (probes #1 and #16), and observed that there is an adequate gap between the underside of the angle and the brick below to accommodate volumetric expansion (Photo 43). Consistent with other flashing methods observed, the flashing at the relief angle does not extend to the outside face of the wall. We did observe minor surface corrosion on the top side of the angle (Photo 44), but to a noticeably lesser extent than at other lintel angle locations. It is likely that since this angle is buried in the wall, its exposure to moisture is less than that of the exposed lintel angles at window and storefront heads.

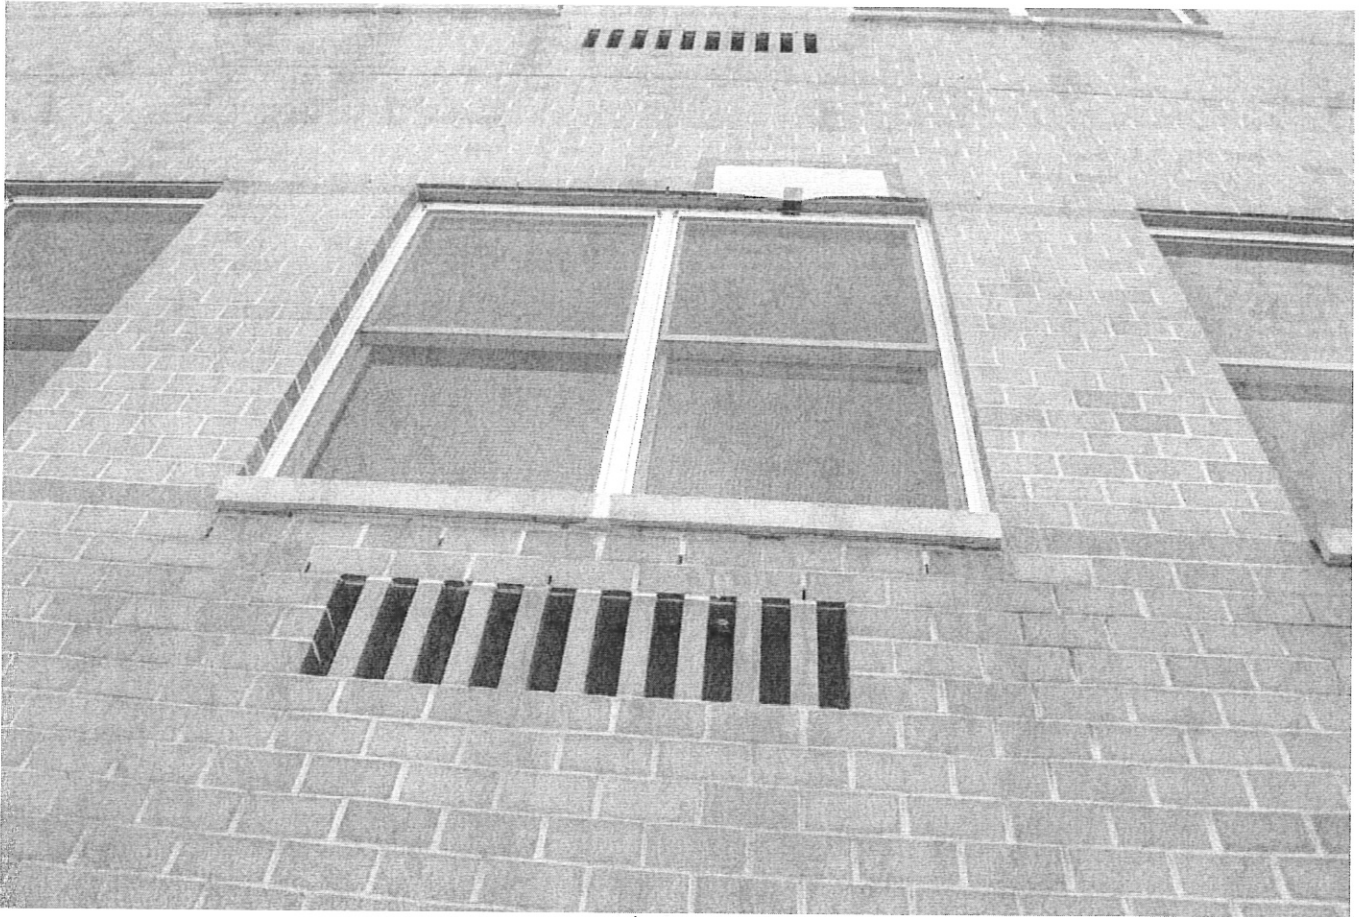
Photo 45

Brick masonry soldier courses were installed at louver openings in the exterior wall of the school (primarily in the classroom wing - Photo 45). Some of these soldier bricks have cracked as a result of volumetric and thermal expansion (Photo 46). The steel lintels above the louver openings appear to be in good condition.

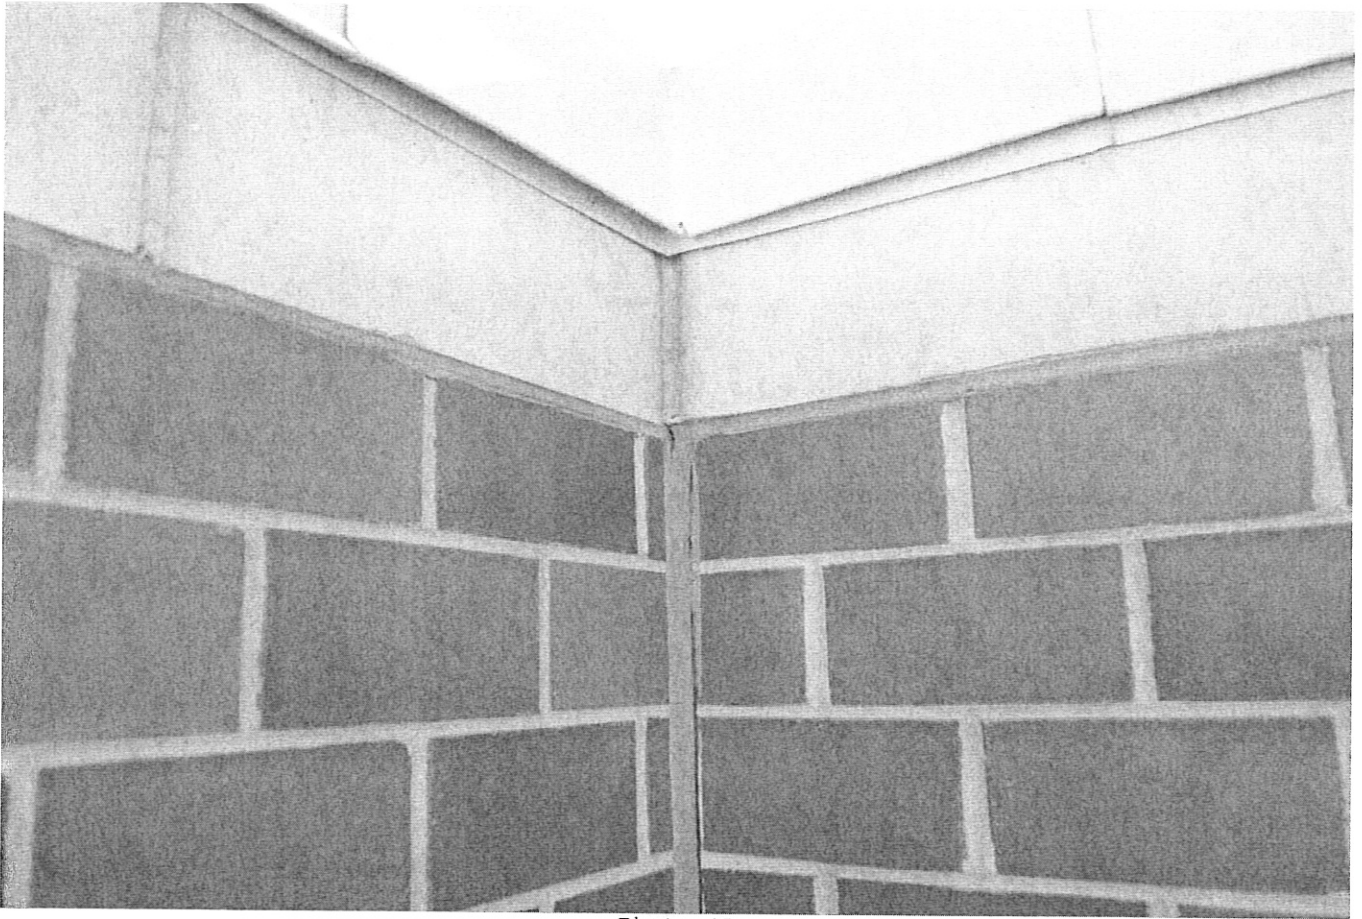
Photo 47

Sealant at control joints, relief angles and at window sill head joints is deteriorating and in need of replacement (Photos 47 and 48). It is likely that the sealant in these joints is from the original construction of the early 1990's. Typically, urethane sealants such as these can have a life expectancy of 10 years, which puts these joints well beyond their anticipated useful life. These joints should be replaced as part of the facade retrofit / restoration project.

- 5.9 Sealant Joints (Medium Priority) - Sealant at control joint, relief angle joint and window sill joint locations should be removed and replaced. We anticipate that this work will include the following:

- a. Removal of sealant material and deteriorated backer rod
 - b. Proper preparation of joint surfaces, including cleaning and priming, as required
 - c. Installation of new backer rod and sealant
