JT2 - Bldg Imp. Masonry Repair

Constructed in 1990-1991, the Intermediate School is a three story steel framed structure clad with brick masonry, architectural stone units, framed (punched) windows, glass storefront areas and cast stone. In the 25 years since its completion, various areas of the building envelope have developed significant signs of deterioration. These areas of deterioration are observed in brick, cast stone components, steel lintels, masonry site walls and sealant joints.

Based on the above, DEI was engaged to conduct a condition assessment of the building envelope to evaluate and determine the causes of deterioration, assess the extent of component damage and develop a preliminary scope and budget for restoration. This investigation phase included close-up observations of conditions using a manlift and cutting probes into various envelope components to facilitate a detailed analysis of the causes of facade deterioration.

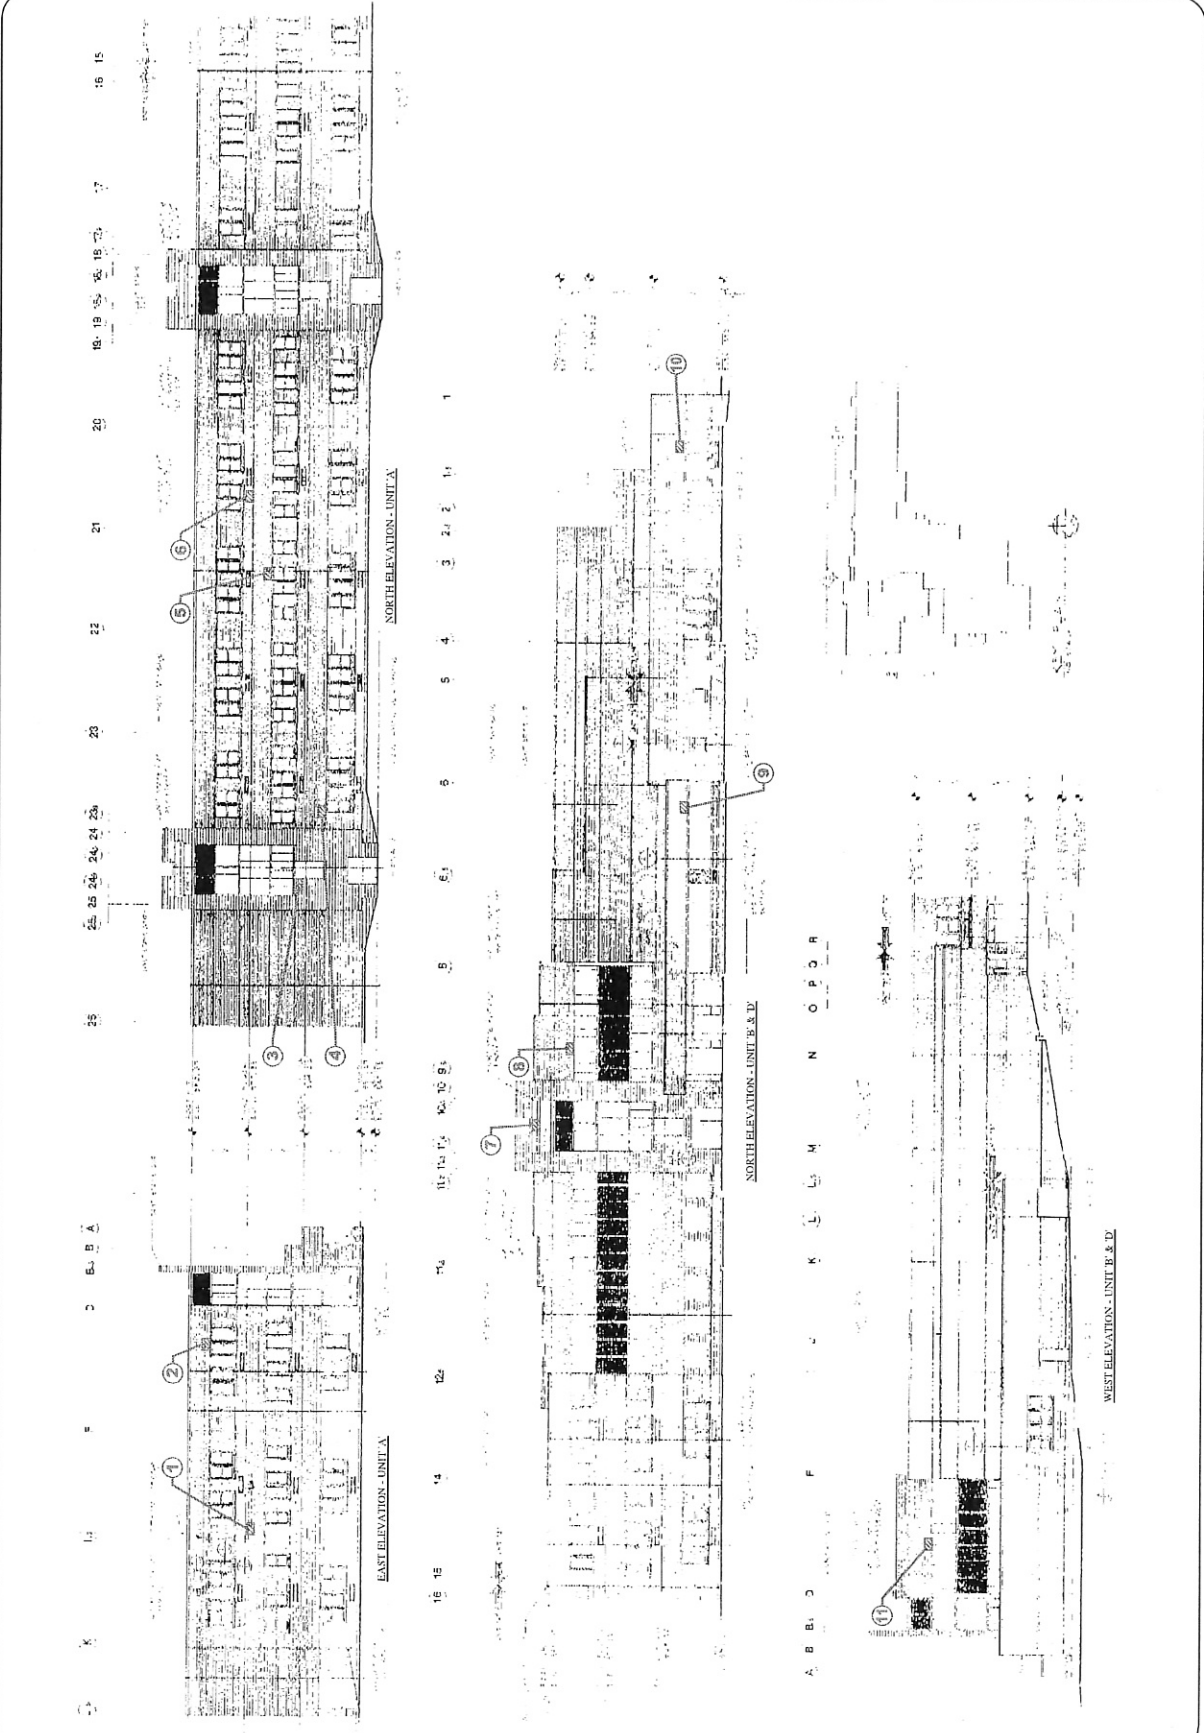
Drawn: SGY
Appd.: RCC
Date: 11/18/16
Scale: NONE
Job No. 287005
Drawing No. SK-1

3. Performed probe openings at selected locations around the building as noted above. Sketches SK-1 through SK-3 identify probe locations on building elevations and site walls. Probe work was executed as follows:

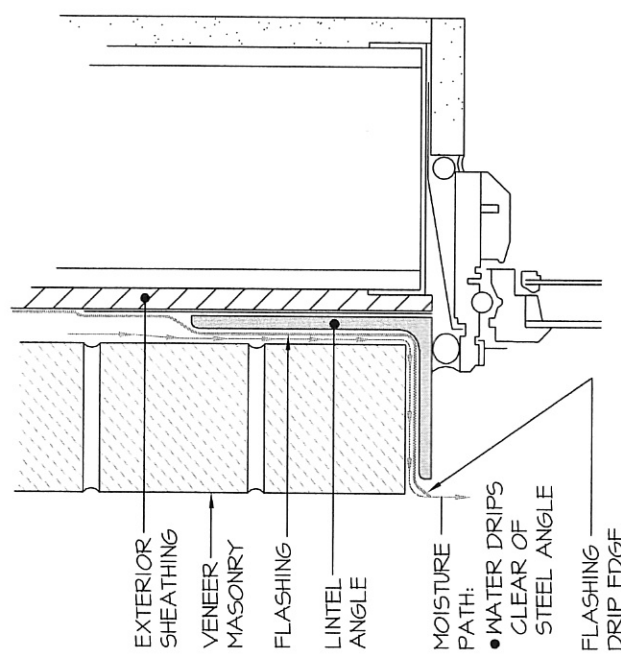
(A) EXISTING CONDITION

1. The flashings that were installed at various steel lintel locations do not extend through the cavity and out beyond the surface of the brick or architectural stone units. The flashings were terminated in the cavity behind the exterior face of the veneer masonry units (Photo 6 from probe #23 and Photos 7 and 8 from probe #19). In this condition, the steel lintel assemblies are unprotected from moisture, and the water that collects in the cavity can flow back under the flashing and sit on top of the lintel without being expelled from the wall (Reference Detail A on sketch SK-4).

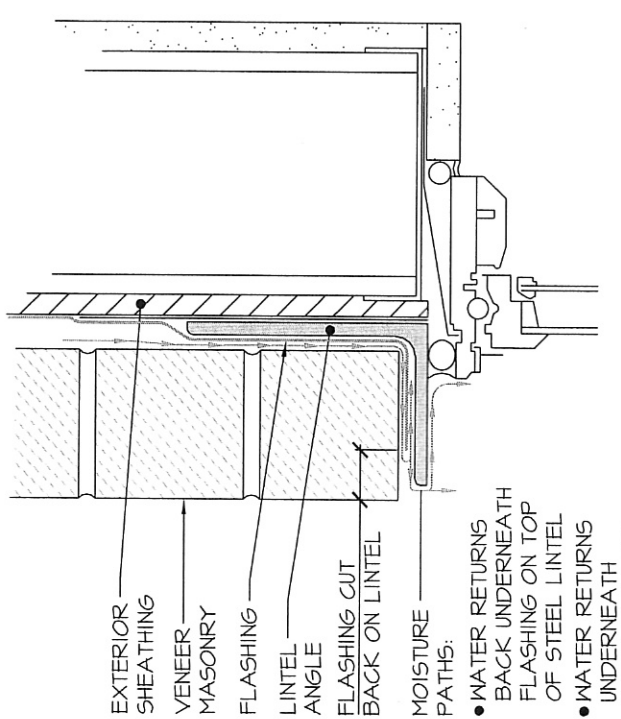
(B) PROPER LINTEL FLASHING

2. Continuous drip edges were not provided at flashing edges. Drip edges are important because they cause water that exits the wall at the flashing line to drip clear of the building face (Reference Detail B on sketch SK-4). In the absence of drip edges, the water is able to return back along the underside of the steel lintels via surface tension and promote corrosion deterioration (Photos 9 and 10).
