HILLMANN
CONSULTING

March 25, 2019

RE: Microbial Investigation – Air Quality Sampling
Middle Smithfield Elementary School
5180 Milford Road
East Stroudsburg, Pennsylvania 18301
Hillmann Project Number: PH-0717

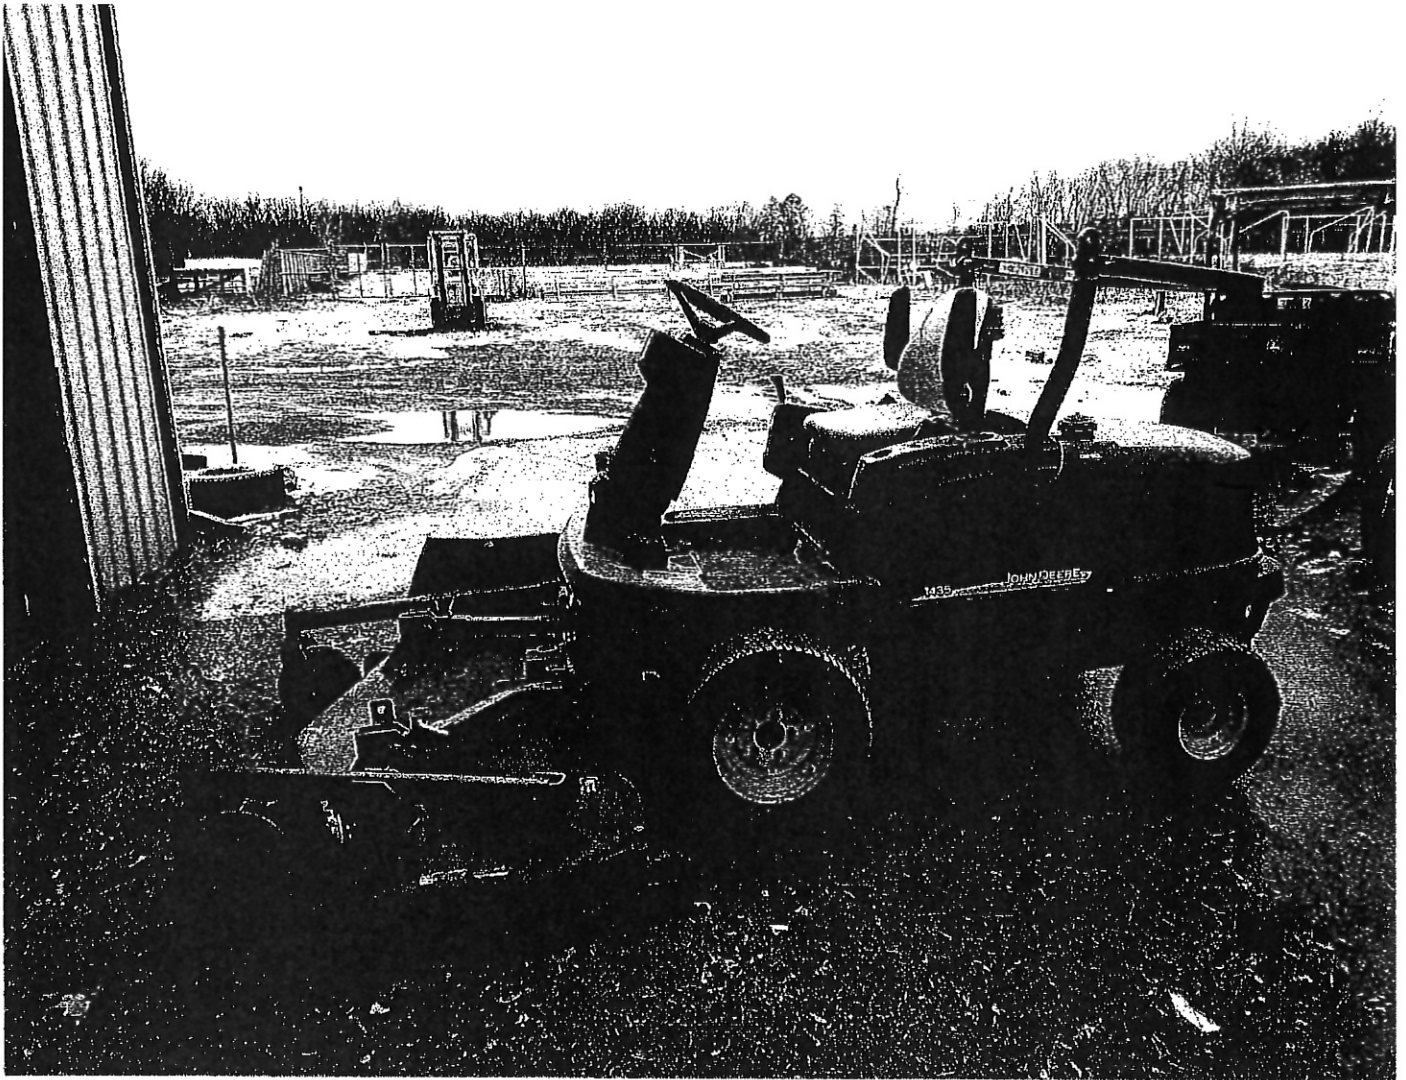
JOHN DEERE	
TYPE	F1400
EEC NUMBER	6*1*74/150-0155
PRODUCT IDENTIFICATION NUMBER	*TC1435D020611*
TOTAL PERMISSIBLE MASS	KG 1500
PERMISSIBLE FRONT AXLE LOAD	KG 950
PERMISSIBLE REAR AXLE LOAD	KG 600
PERMISSIBLE TOWABLE MASS	
UNBRAKED	KG 400
INDEPENDENTLY BRAKED	KG 400
INERTIA BRAKED	KG 400
HYDRAULIC OR PNEUMATIC BRAKED	KG -
DEERE & COMPANY MOLINE, ILLINOIS USA	1435 DSL FAT MOWER ABS CORE 0.68
