JT2 - Bldg Imp. Masonry Repair

Constructed in 1990-1991, the Intermediate School is a three story steel framed structure clad with brick masonry, architectural stone units, framed (punched) windows, glass storefront areas and cast stone. In the 25 years since its completion, various areas of the building envelope have developed significant signs of deterioration. These areas of deterioration are observed in brick, cast stone components, steel lintels, masonry site walls and sealant joints.

Based on the above, DEI was engaged to conduct a condition assessment of the building envelope to evaluate and determine the causes of deterioration, assess the extent of component damage and develop a preliminary scope and budget for restoration. This investigation phase included close-up observations of conditions using a manlift and cutting probes into various envelope components to facilitate a detailed analysis of the causes of facade deterioration.

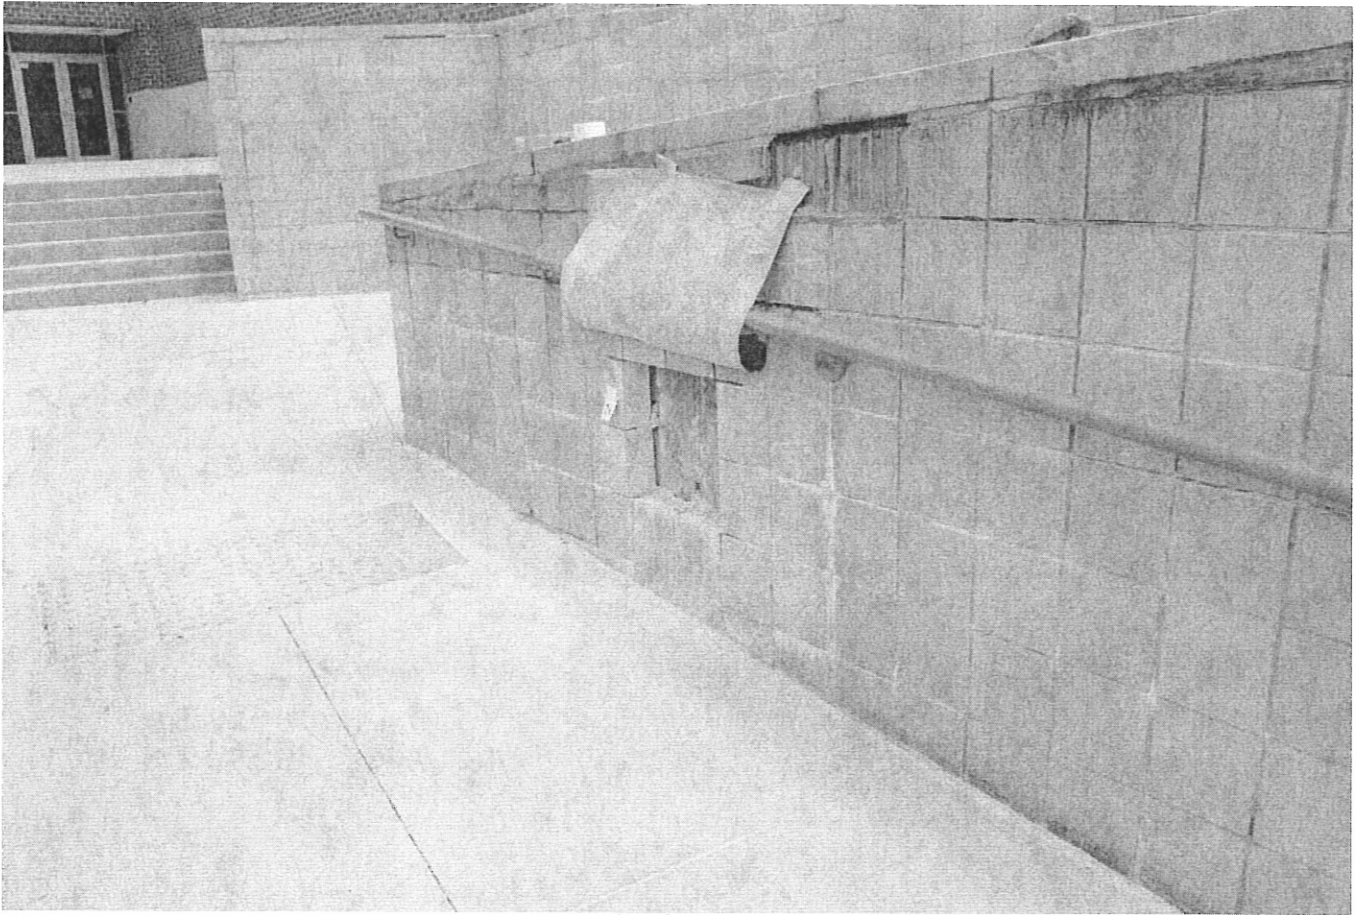
Photo 39

A broken piece of cast stone cap was removed to observe the flashing conditions below the cap. A stainless steel flashing is present below the caps; however, the flashing is held back 2" from the exterior face of the veneer below (Photo 38). Thus, water entering through cracks or joints in the caps drains off either side of the flashing directly into the top of the architectural stone veneer (Reference sketch SK-6). As damage occurred in the veneer, more openings were created which further increased moisture intrusion and additional deterioration (Photo 39).

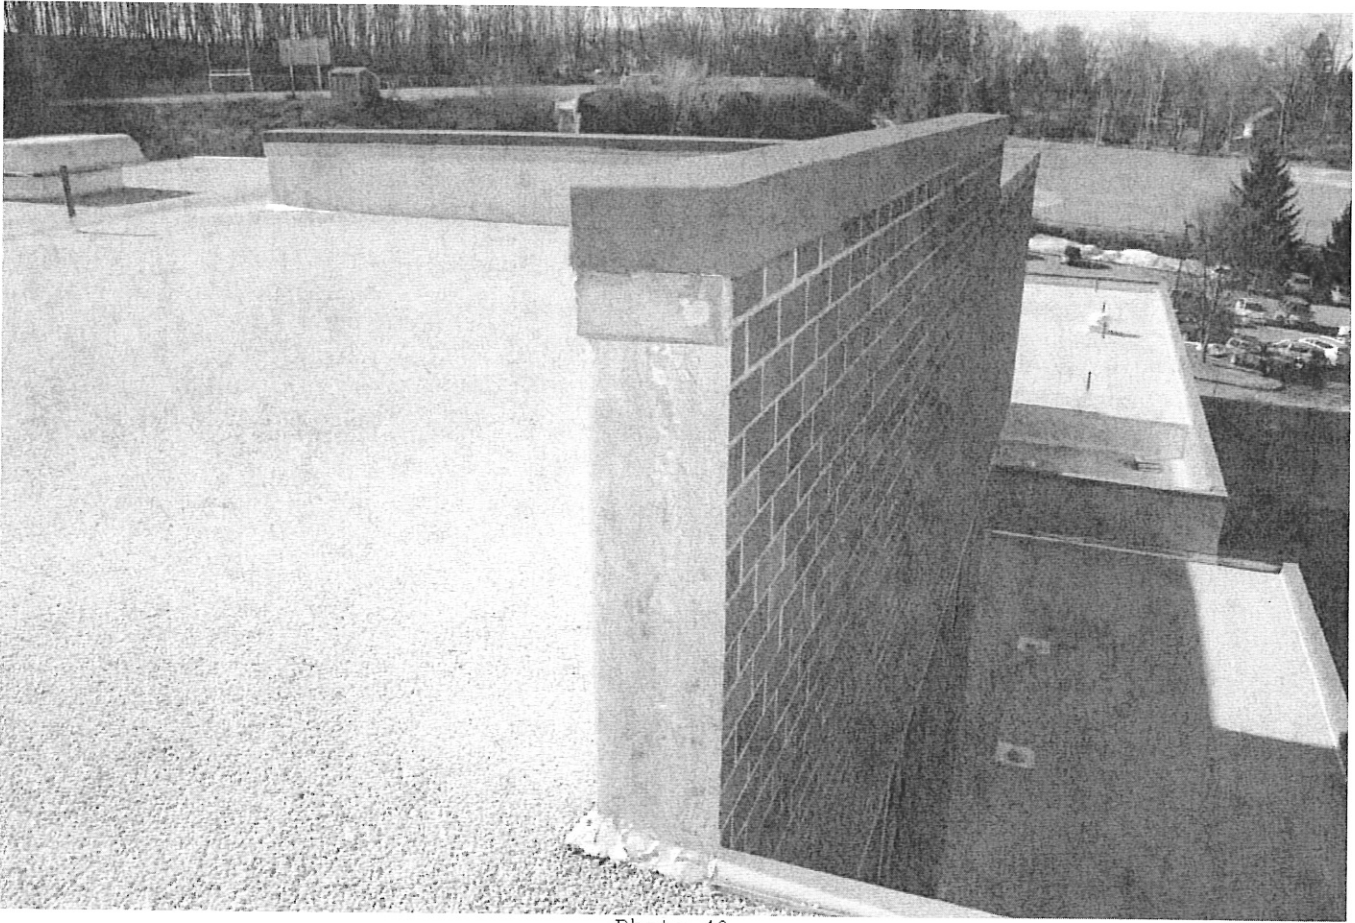
Photo 49

Bronze colored metal coping caps were apparently installed at some time after the original construction to replace deteriorated cast stone coping pieces. It appears that these metal caps were field fabricated and are affixed to the parapet with external attachments (Photos 49). Some of these copings (approximately 480 linear feet) will need to be removed and replaced in order to execute repair recommendations noted in this report. Given the poor condition of some of the coping caps to remain (Photo 50), the District may wish to consider replacing the balance of the bronze coping caps (approximately 600 linear feet) as part of this project. Additional cap replacement is not included in the repair budget estimate.

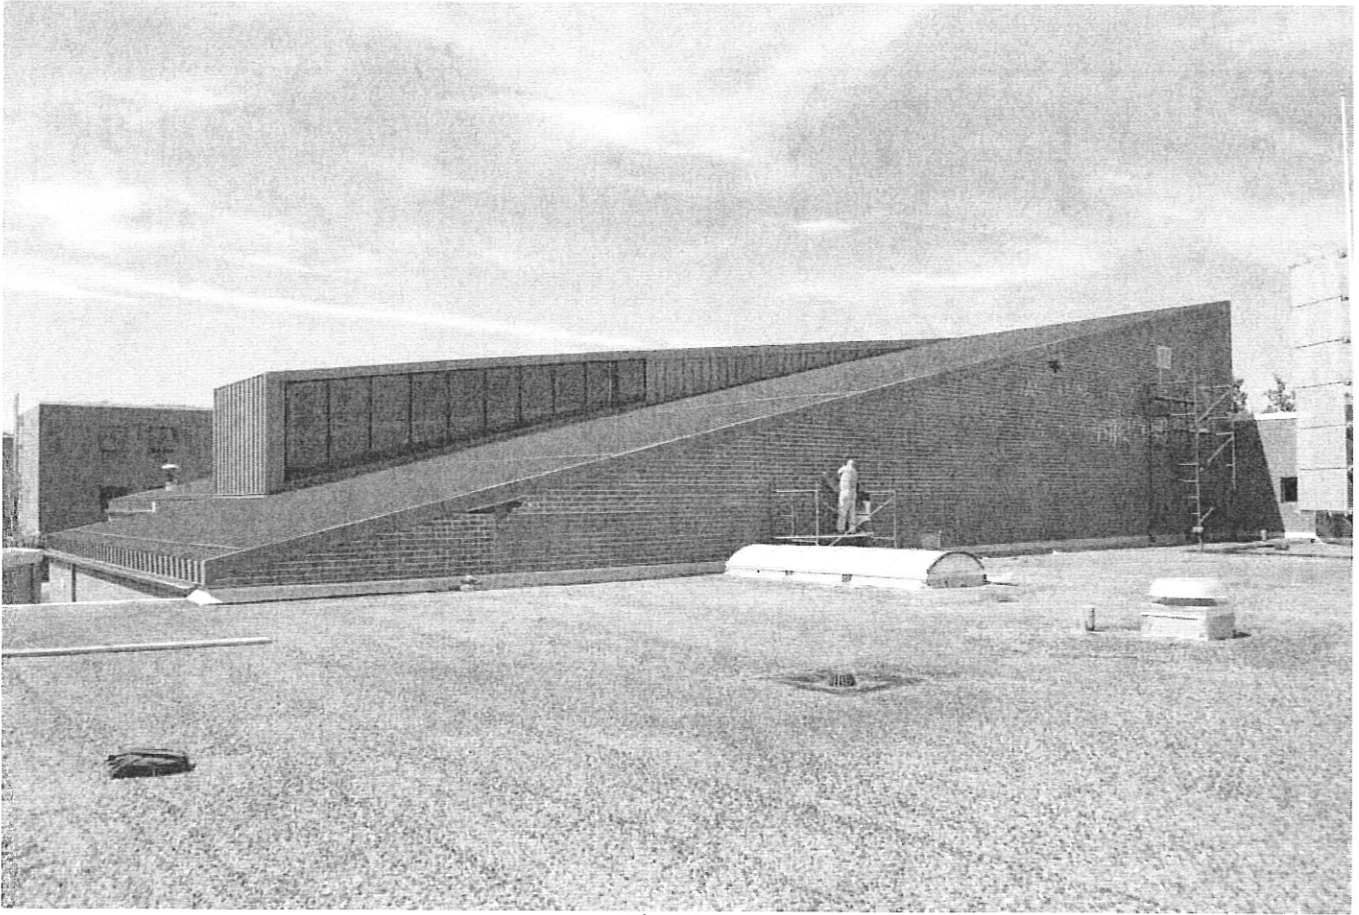
Photo 1

The natatorium walls at North High School consist of brick masonry tied back to concrete masonry unit (CMU) back up walls laid up within, and supported by, the structural steel framing of the building. Photos 1 and 2 depict the north wall and south wall elevations, respectively. The design calls for a 4" cavity between the brick veneer and CMU backup that includes ½" of parging over the CMU, 3" of spray foam insulation and ½" of air space directly behind the brick veneer (Reference Sketch SK-2, which shows the cross-sectional view of the north wall of the natatorium as provided on Sheet 151 of the original architectural drawings).

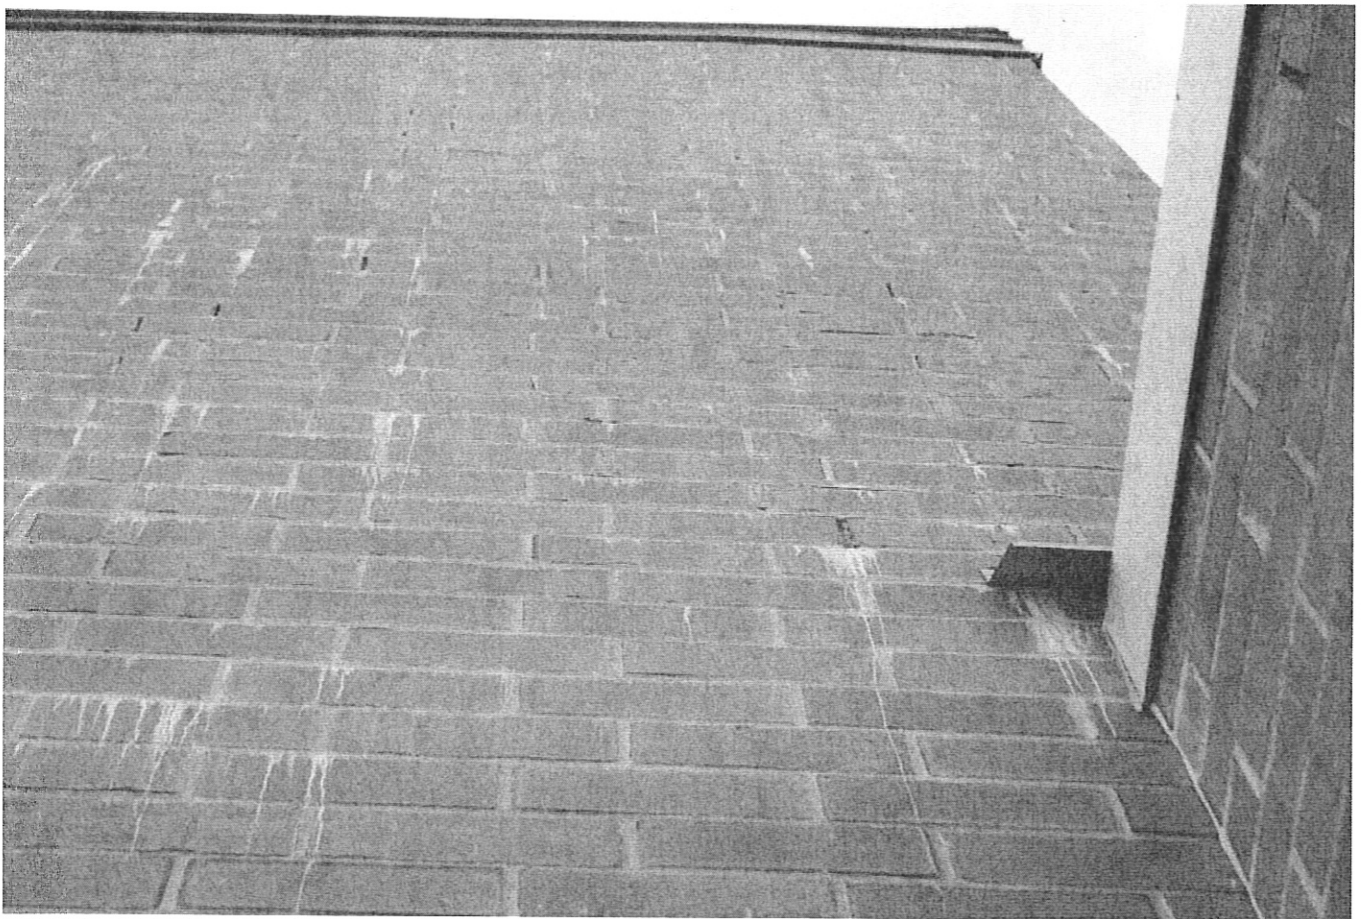
Photo 7

Efflorescence was also widespread on the exterior surface of the wall (Photos 7 and 8). Efflorescence is a white, powder-like deposit caused by soluble minerals within the wall being carried to the face of the wall by moisture and deposited as residue when the water evaporates. These mineral deposits evidence that this wall is absorbing abnormally high amounts of moisture, which is likely due to the increased porosity of mortar that had frozen prior to full cure.

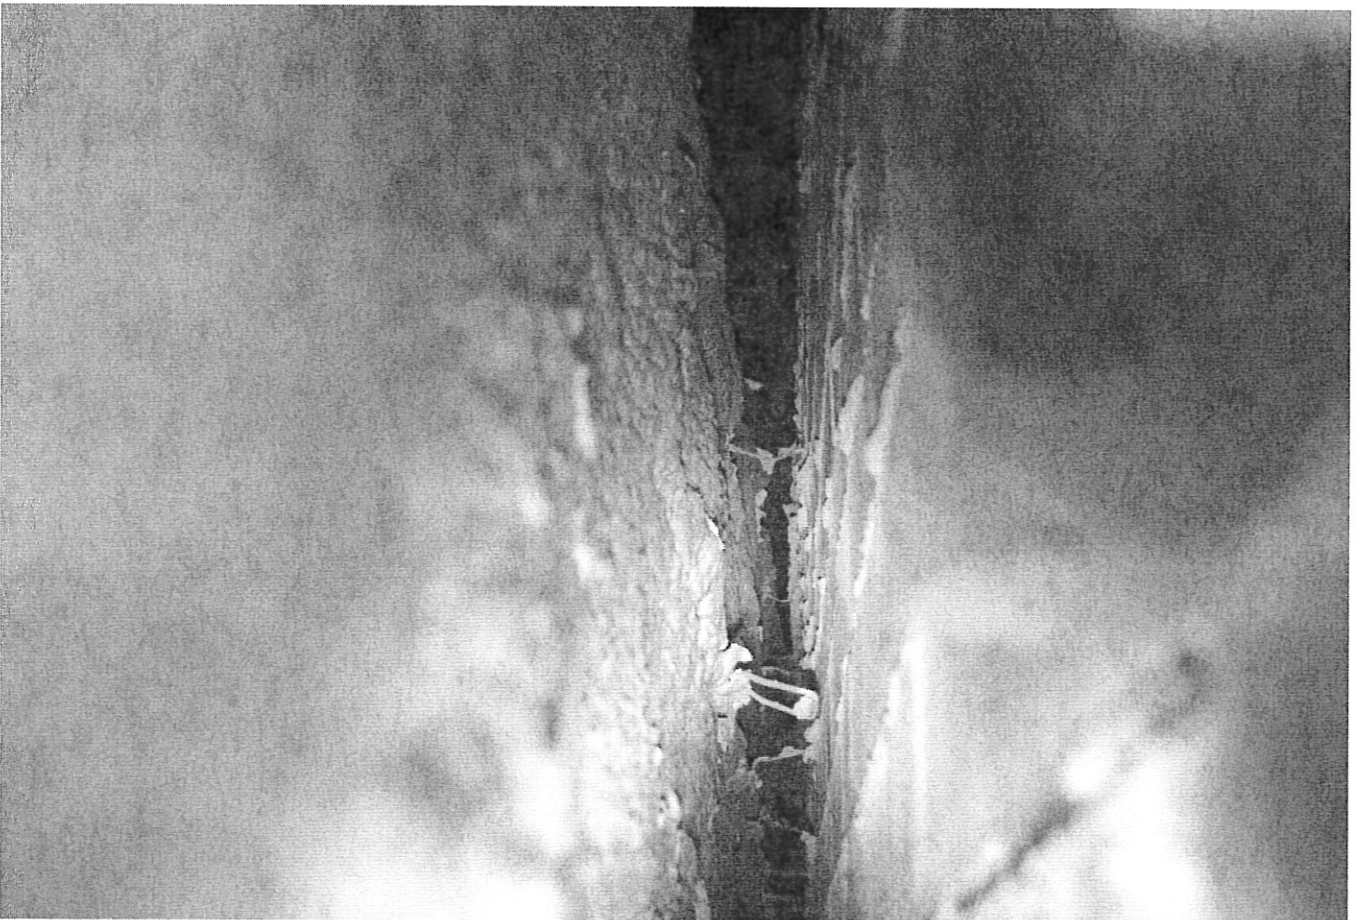
Photo 9

Probes into the wall also revealed areas where brick ties were not engaged between the CMU backup wall and the brick veneer (Photos 9 and 10). The lack of lateral support has enabled the wall to shift outward, resulting in the out of plane movements observed at some locations.

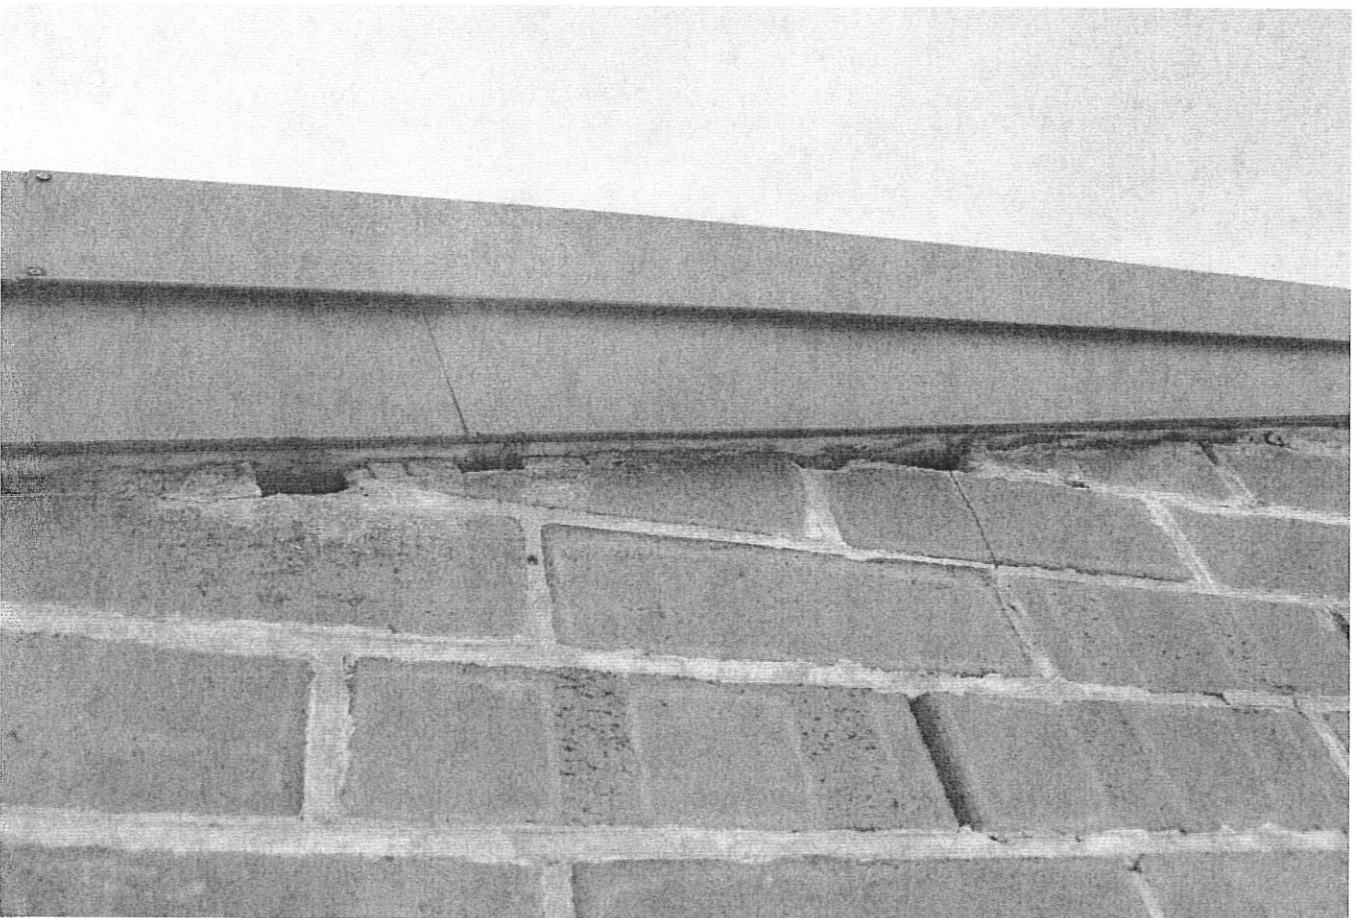
Photo 11

The fascia follows the slope of the roof and slips up under the roof edge cap and is attached back to wood blocking. As noted earlier, the drawings call for only a 1" overlap of the brick. Our field observations indicate that even this minimal overlap was not achieved at some locations (Photo 11), and the blocking behind the fascia at some places is not flush with the face of brick and remains exposed (Photo 12). There also appears to be inadequate accommodation of thermal movements in the metal edge and fascia assembly. At some fastener locations, localized distortion of the metal pieces and fasteners was observed (Photos 13 and 14).

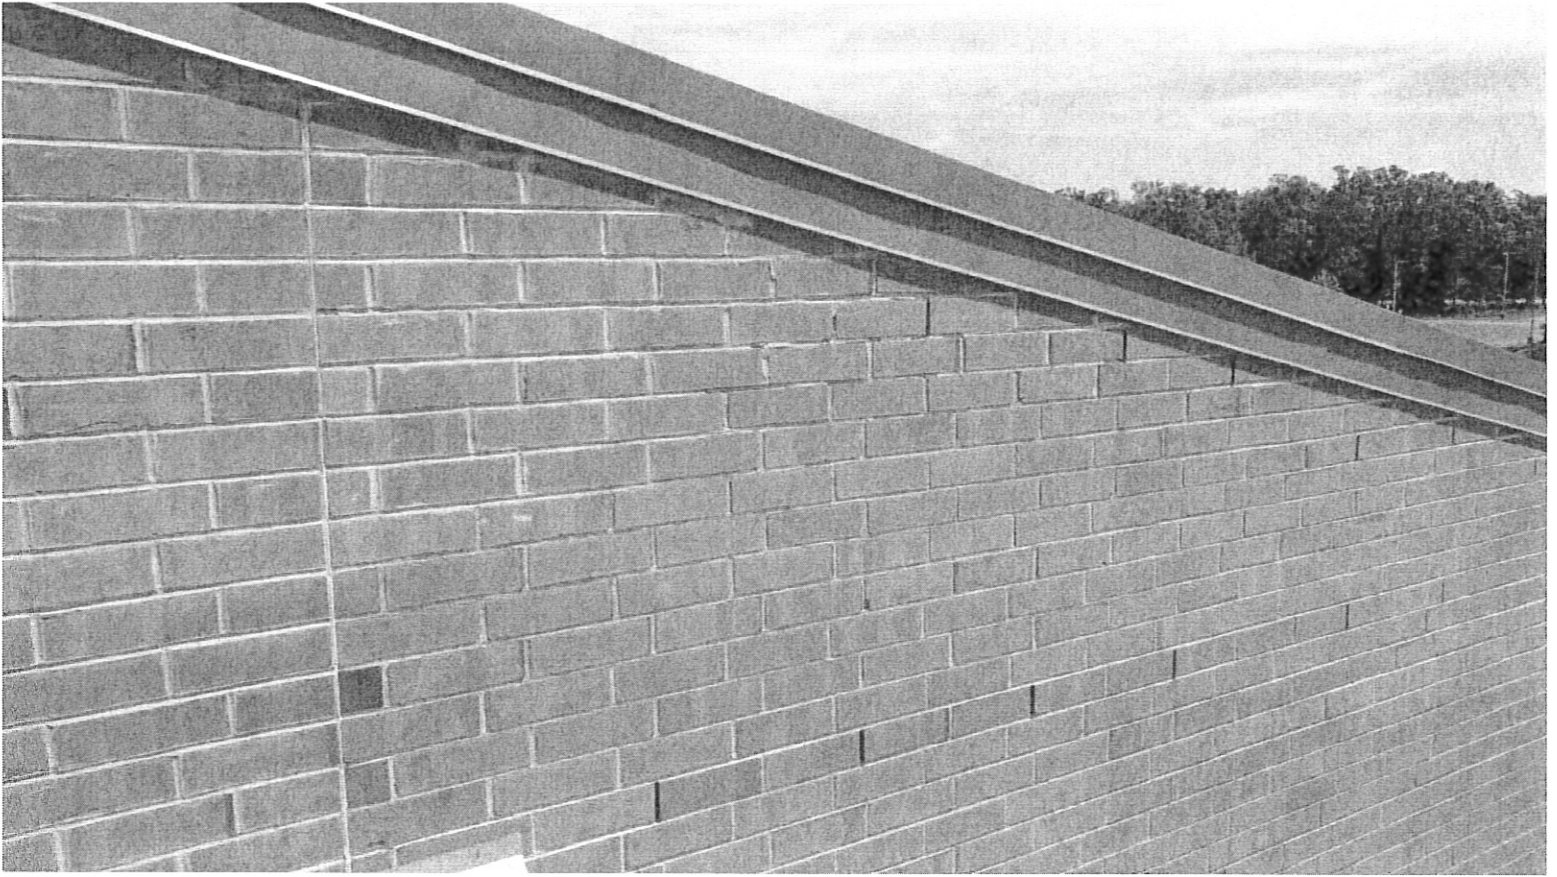
Photo 16

The section of the south wall that is accessible from an adjacent roof has been repointed recently (noted in Sketch SK-1), and appears to be performing adequately (Photo 16). The south wall evidences some joint deterioration, particularly on the upper areas of the wall, but to a much lesser extent than on the north wall (Photos 17 through 20). Lower areas of the south wall appear to be in adequate condition.
